Clock Room Floor Repairs

With the support of the Warminster Town Council these essential repairs were undertaken by Moulding's using a Community Infrastructure Levy (CIL) grant.

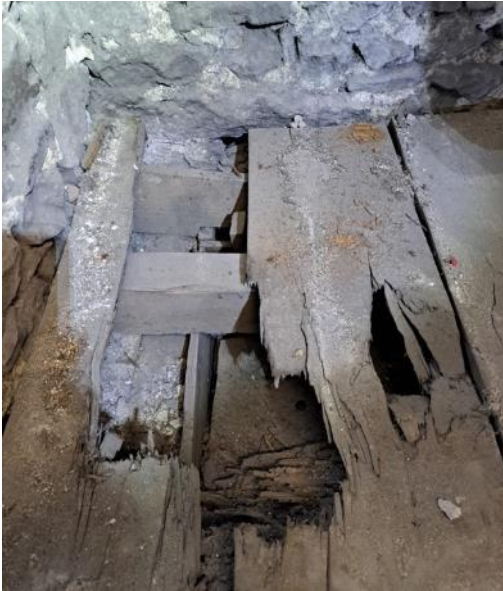
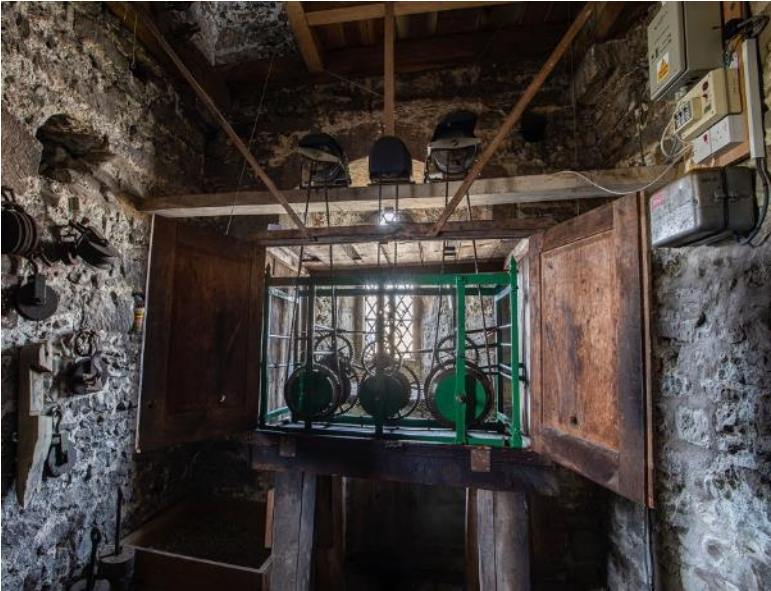
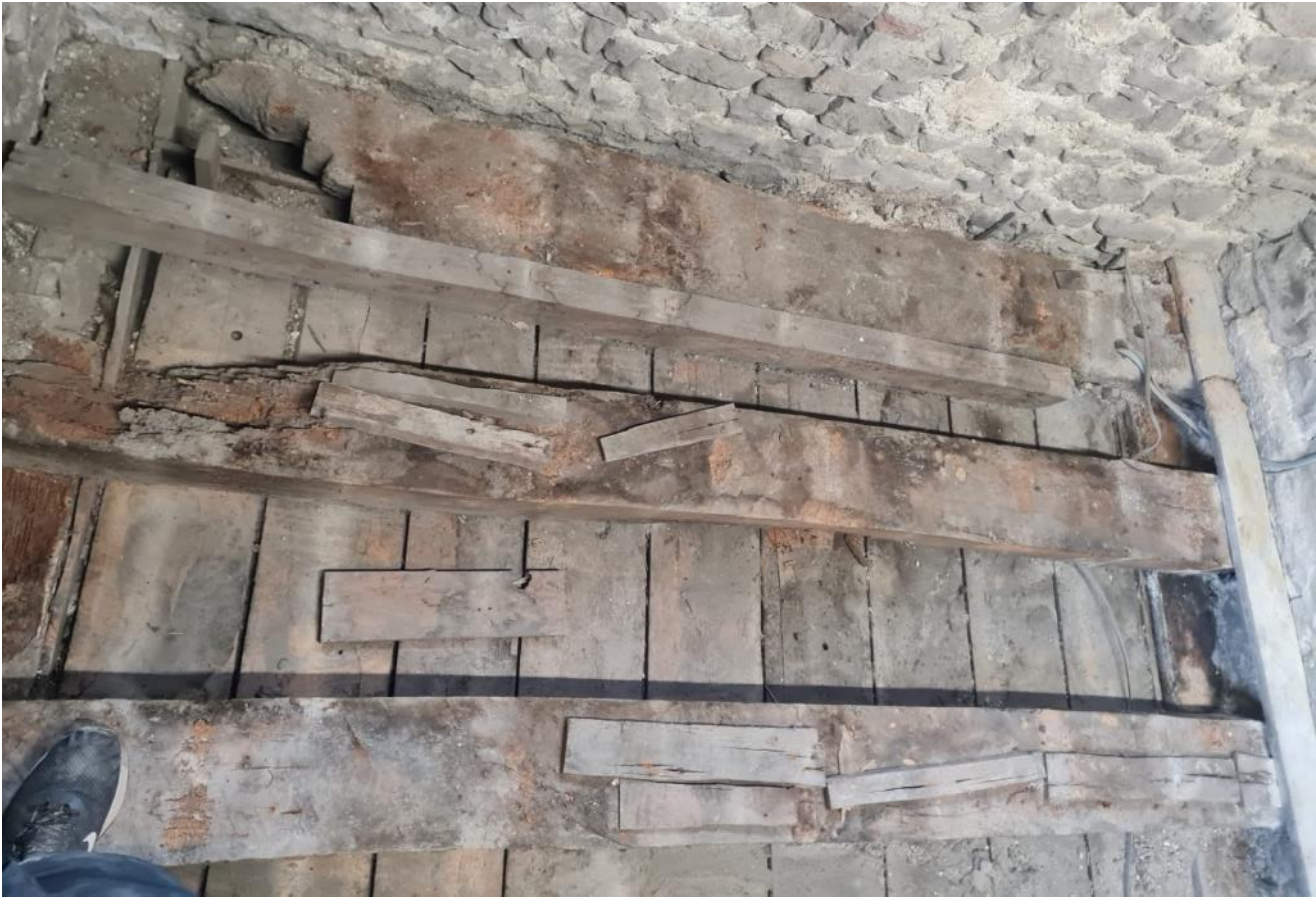
After experiencing issues with the clock mechanism it was noted that several beams had failed under the clock and the floor had dropped. Upon inspection this was caused by decay to the beam ends and historic damage from falling clock counter weights (60+ years ago).

Andrew Waring (Structural Engineer) undertook a full survey and confirmed that 3 of the 13th century beams had failed (One near the door entrance and the other two under the clock mechanism). In conjunction with the Conservation officer, the Chapel architect and Moulding's it was agreed that 3 new oak beams would be installed in parallel and bolted to the failed beams. Once the floor was lifted all other beam ends would be inspected and wedged. The floor re-laid and boarding repaired.
