St Lawrence Chapel Warminster

Nave roof inspection and cleaning of the gutters

Nave roof inspection and cleaning of the gutters 6th July 2023

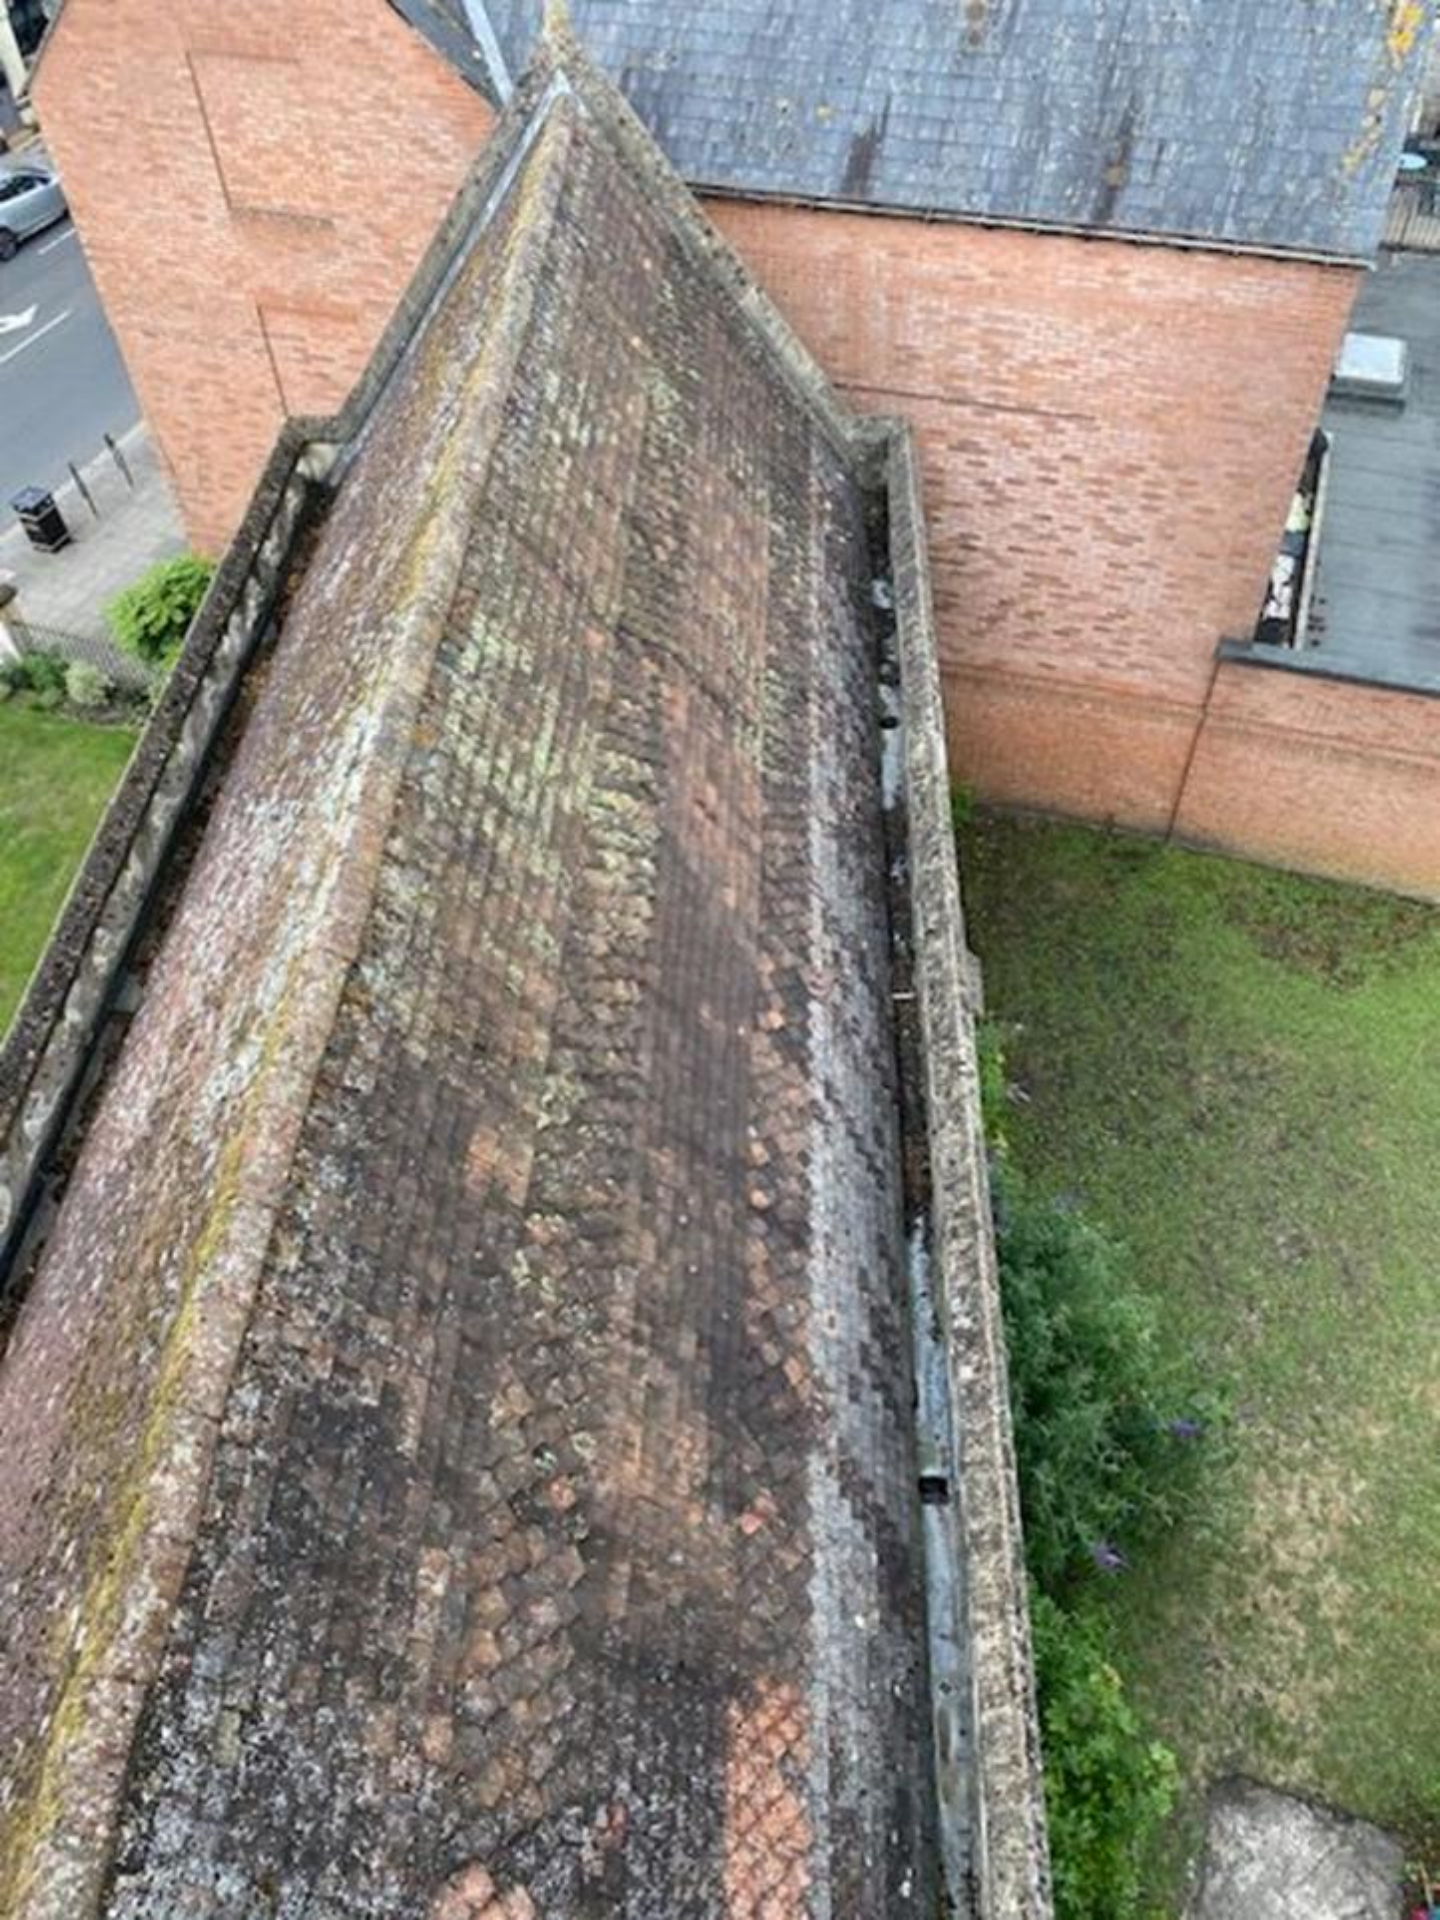
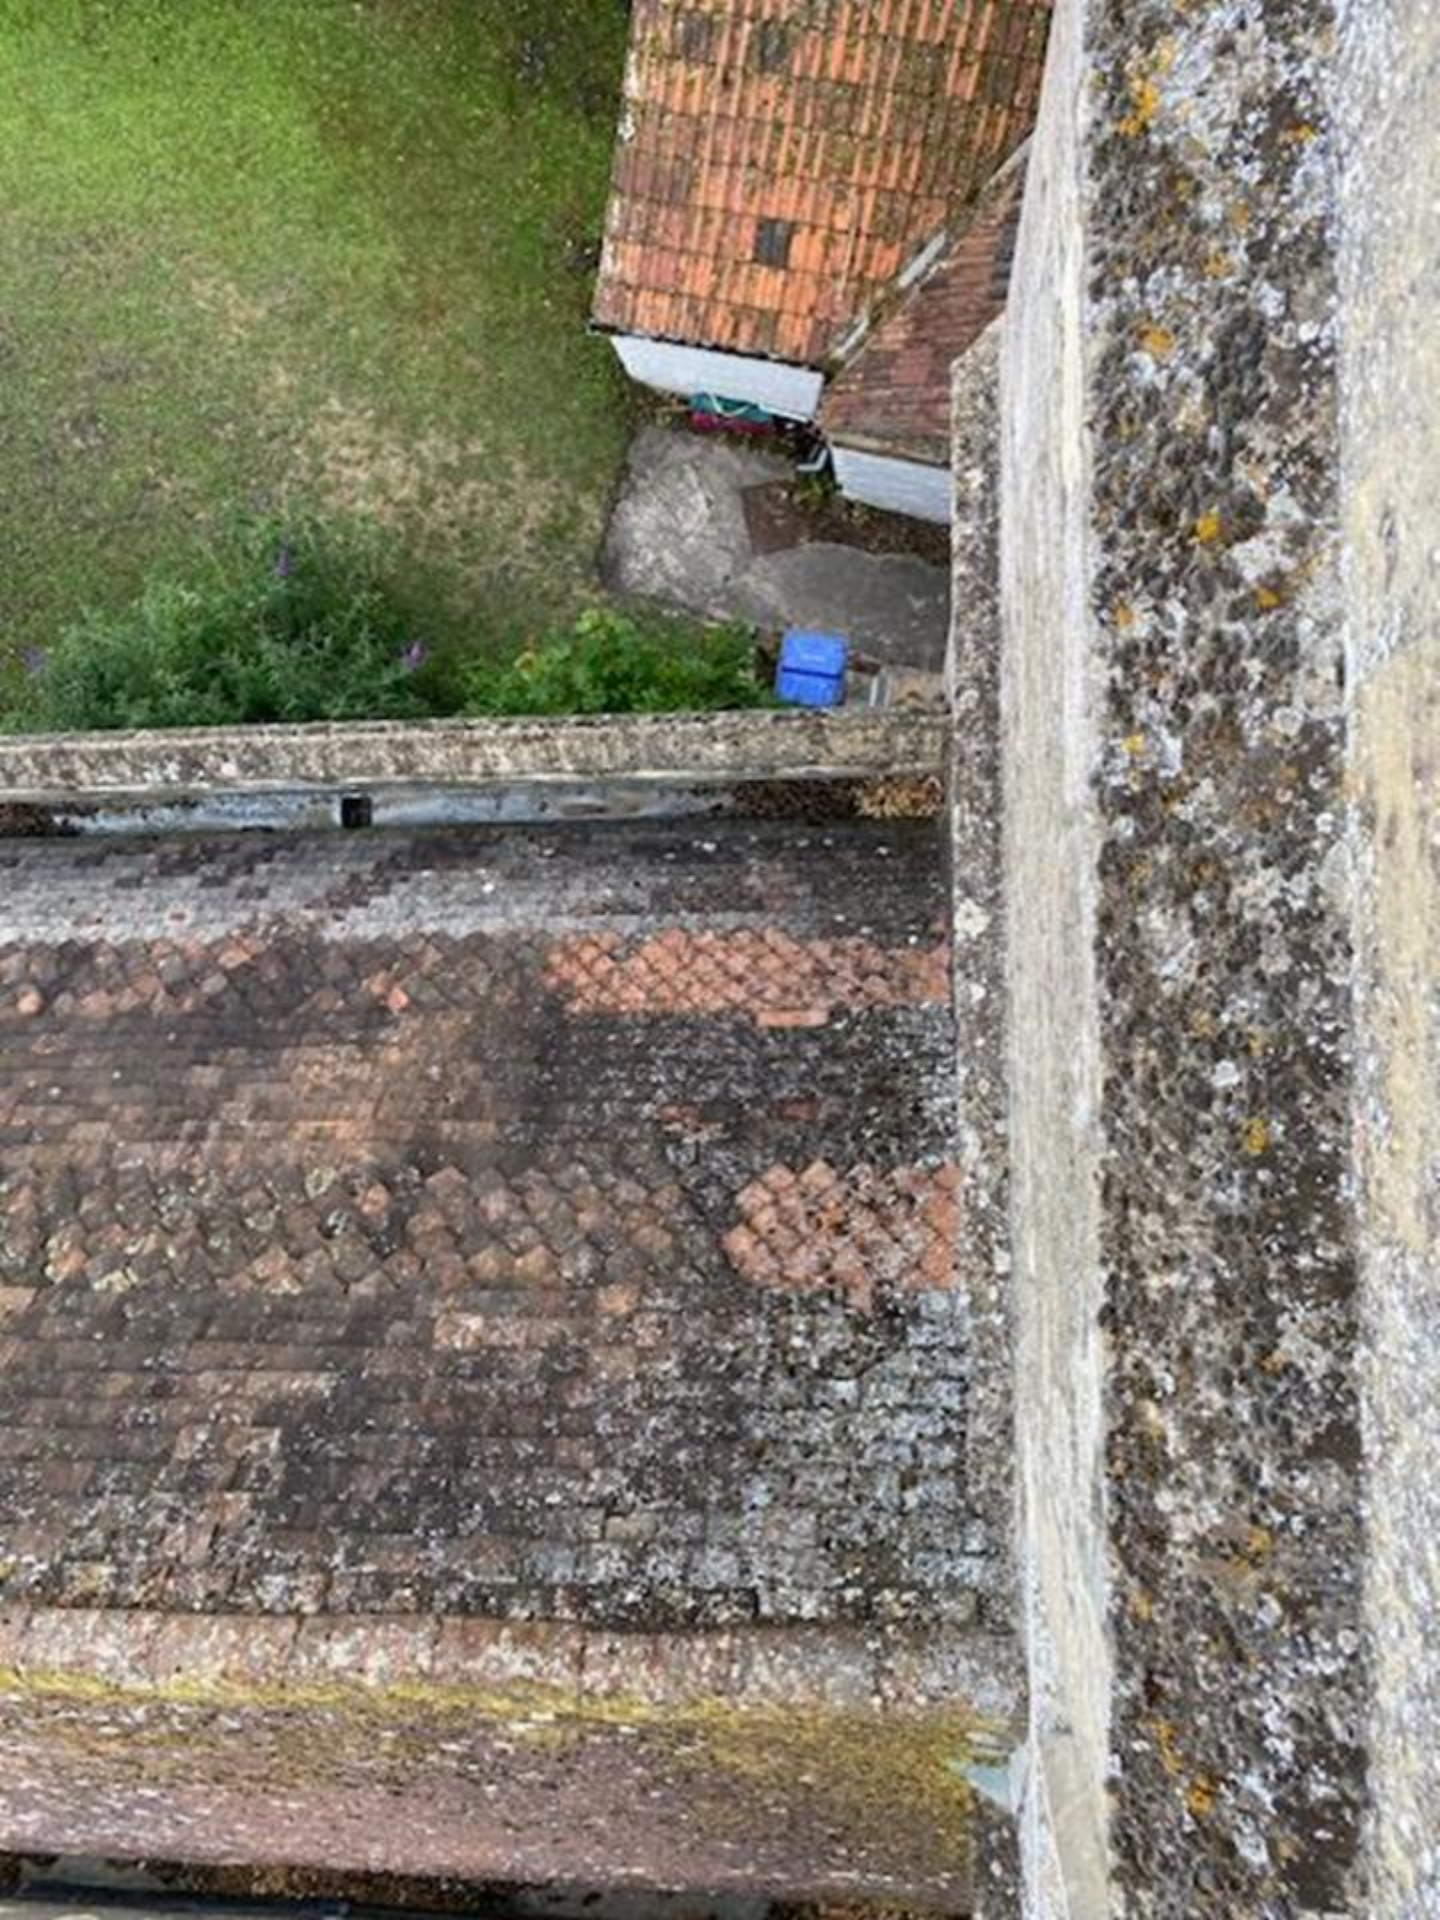
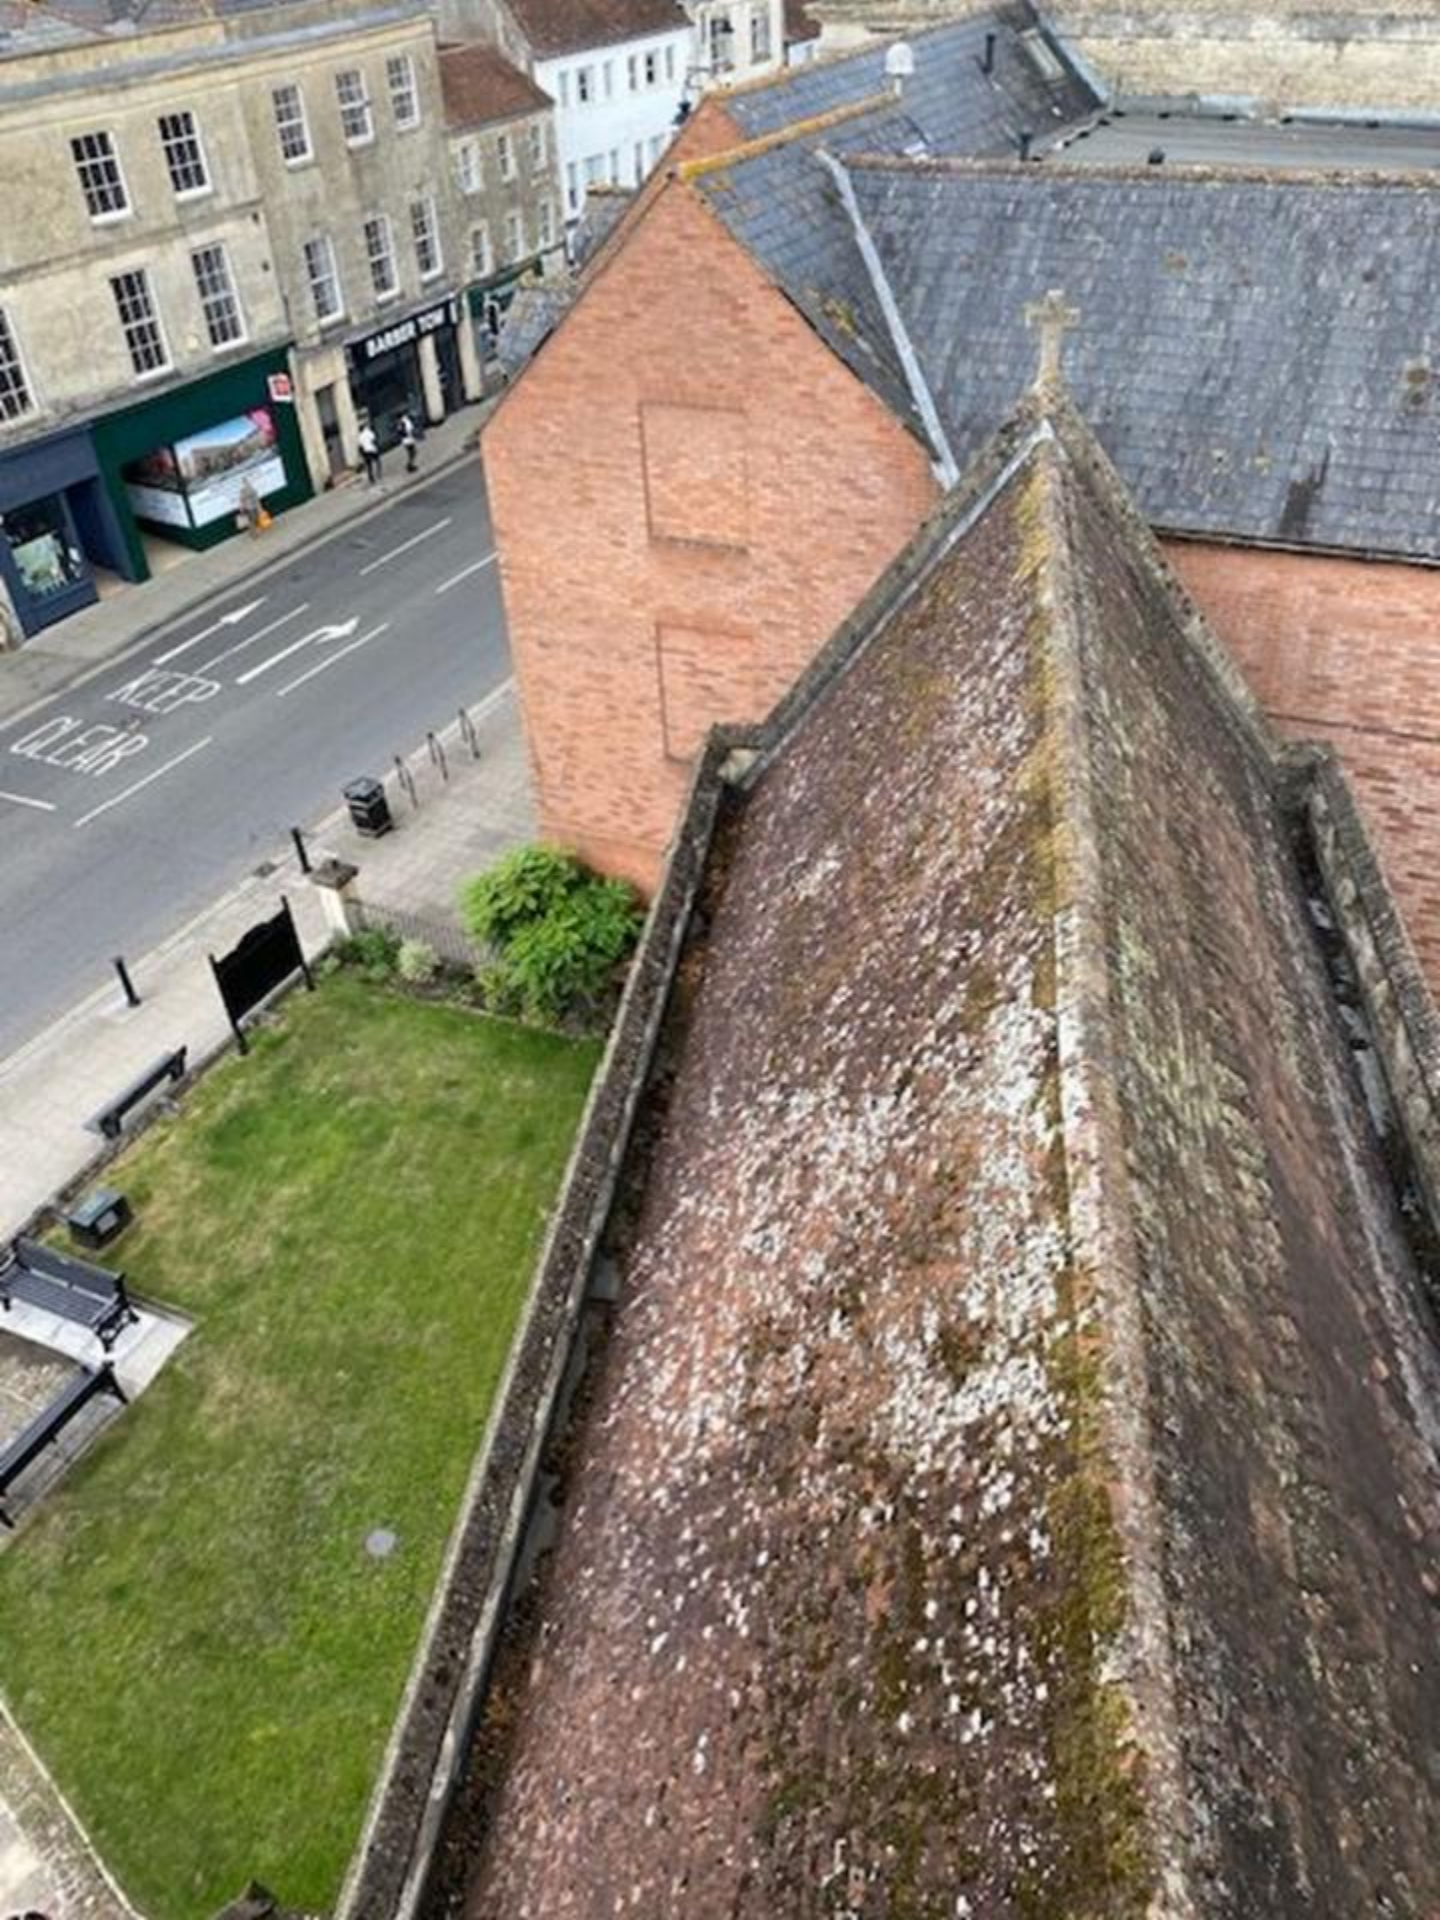
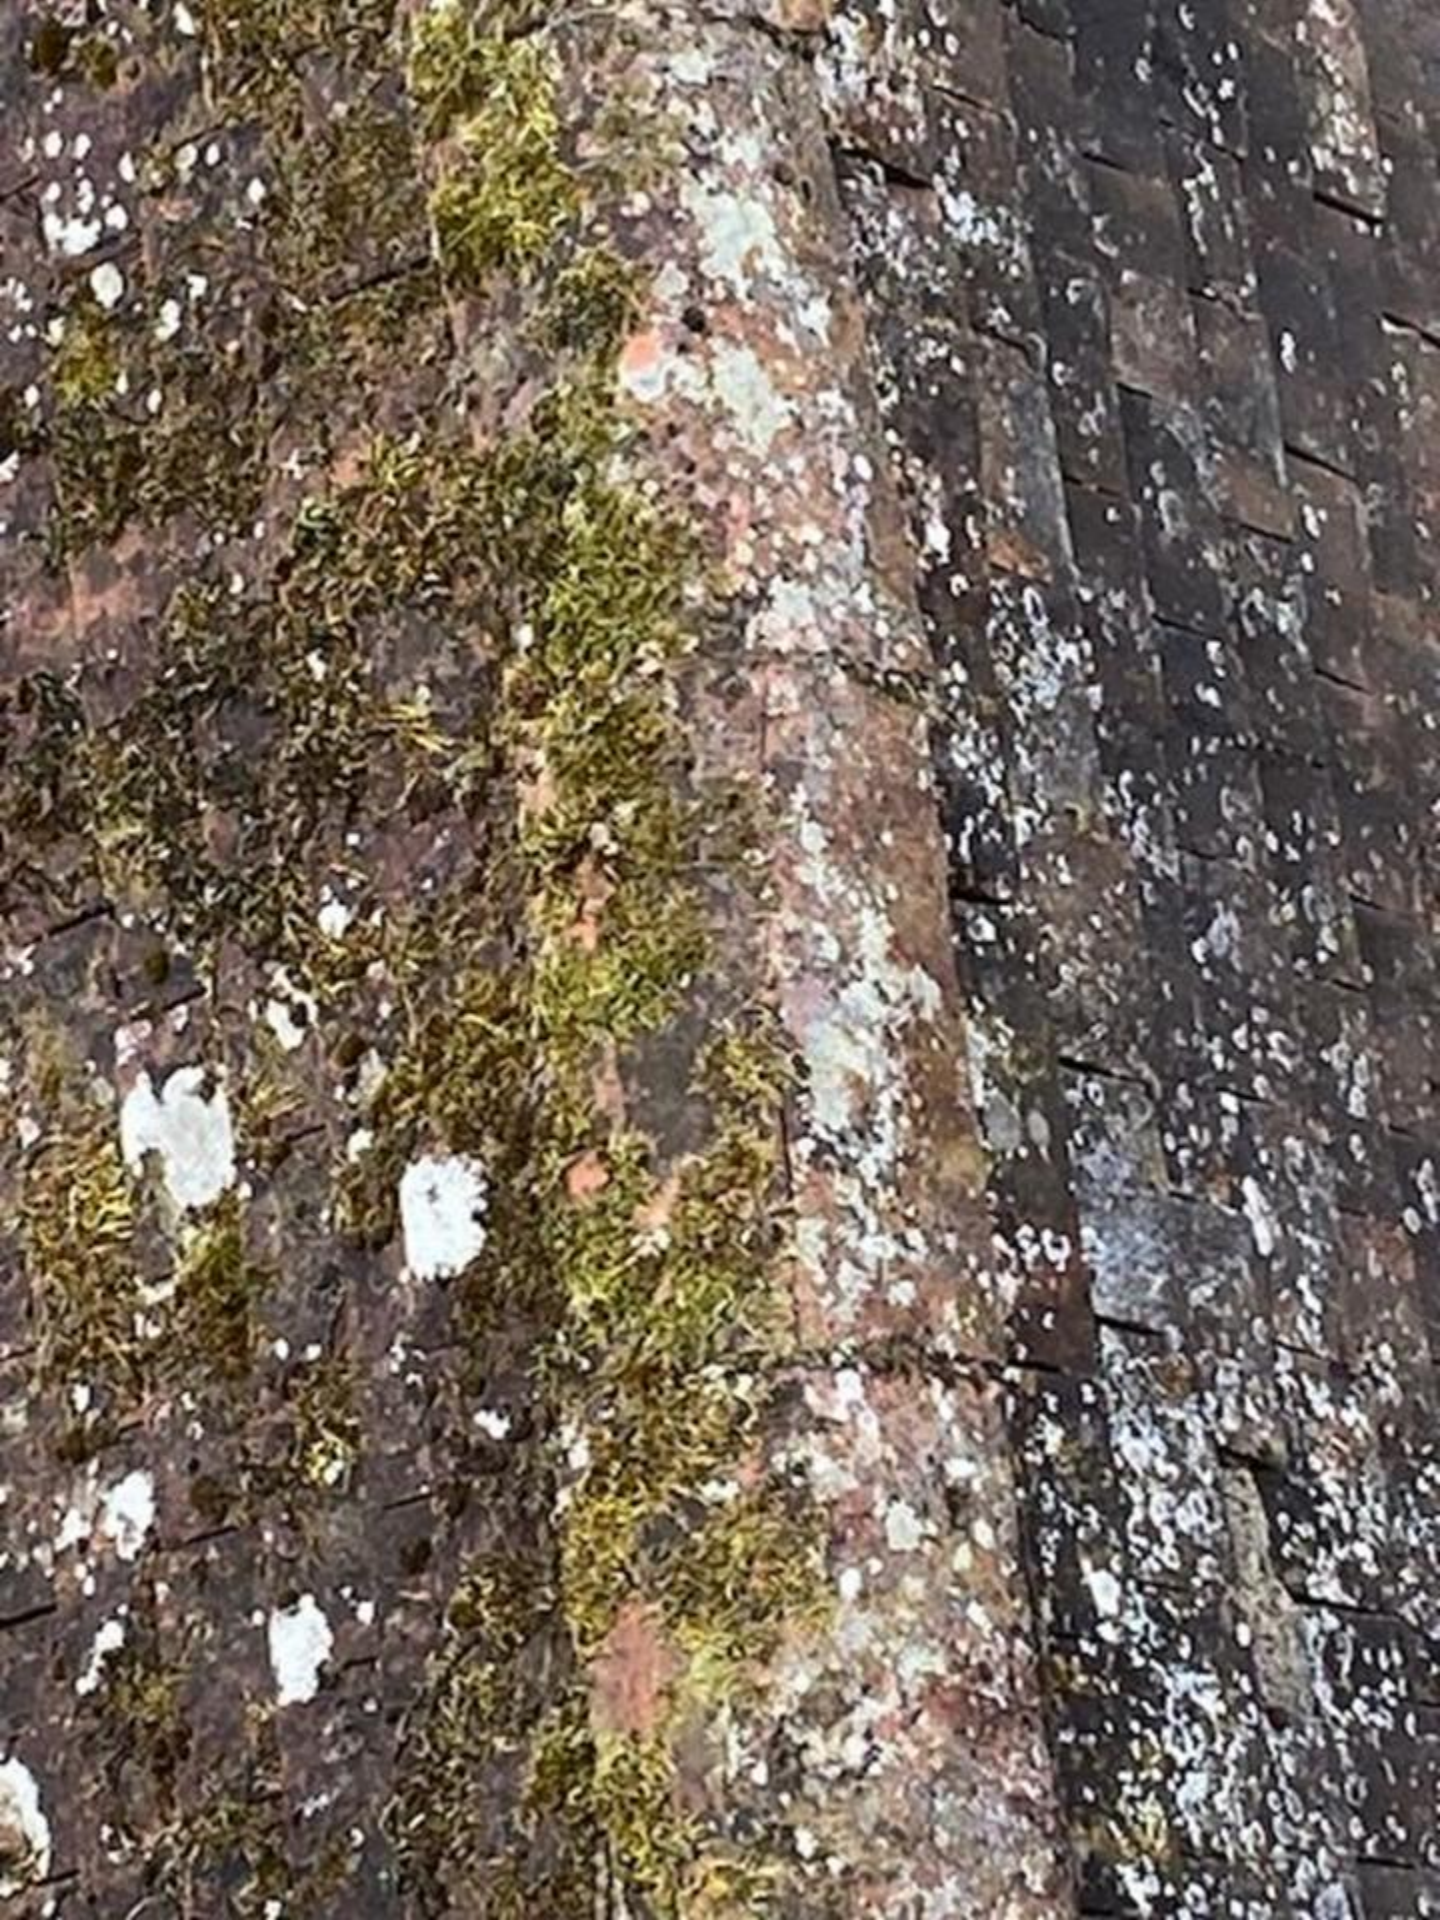
The roof battens and felt seem to be in very good condition. The roofer has clean the debris from the lead gutters on both sides of the chapel and replaced some missing tiles, the roof seems to be in very good condition. The cover lead flashing to the decorative parapet is starting to come away in area because the mortar pointing is on the move.

Inspection of felt
and batons.

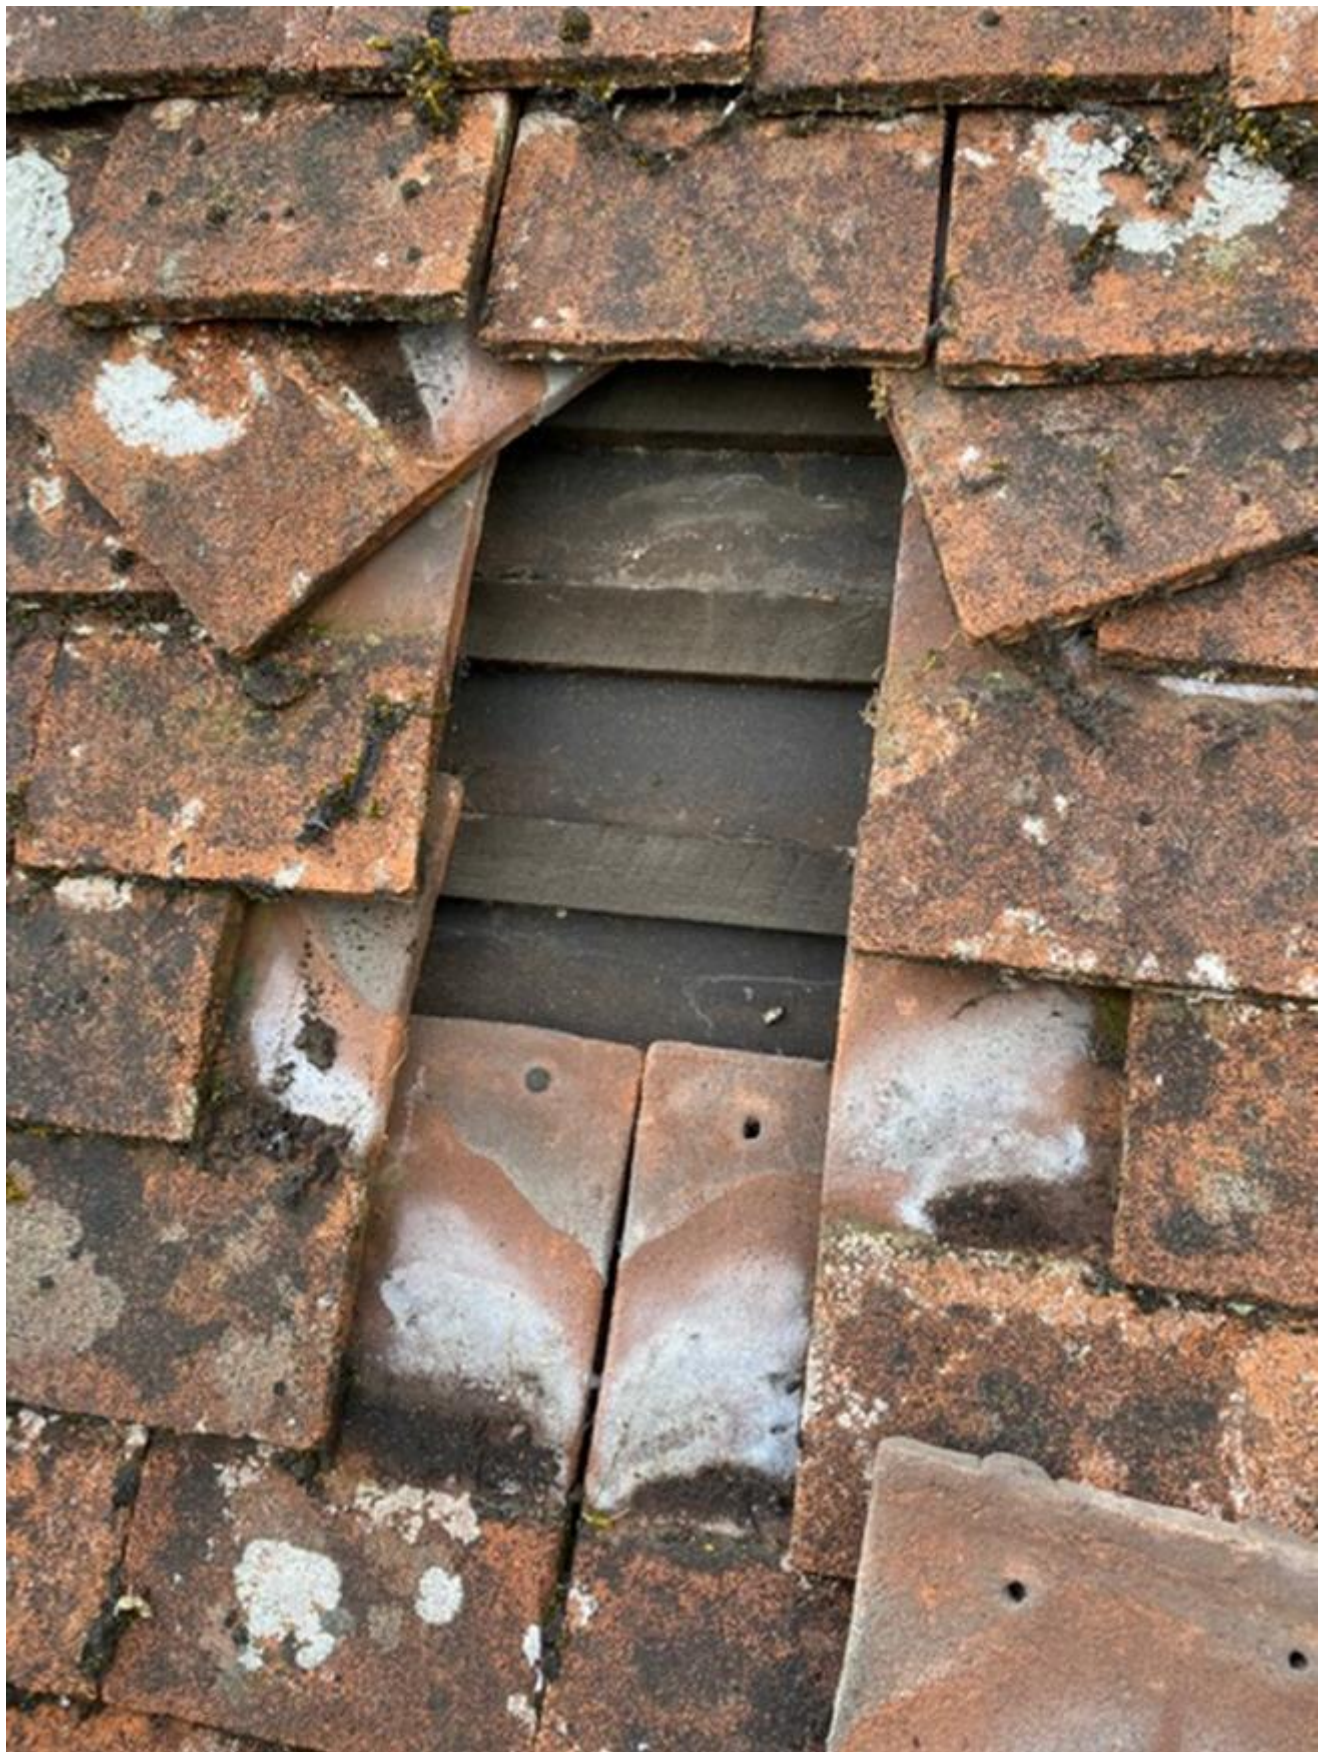
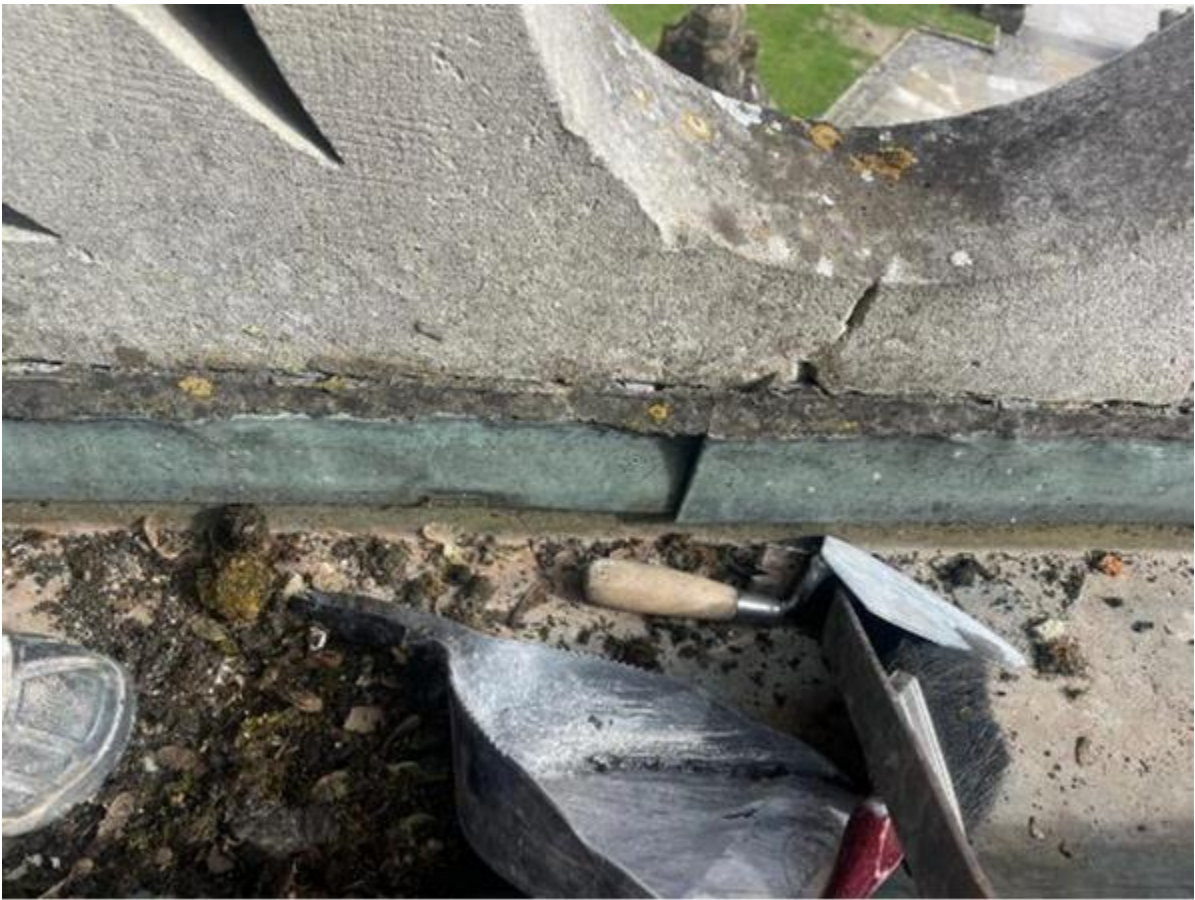
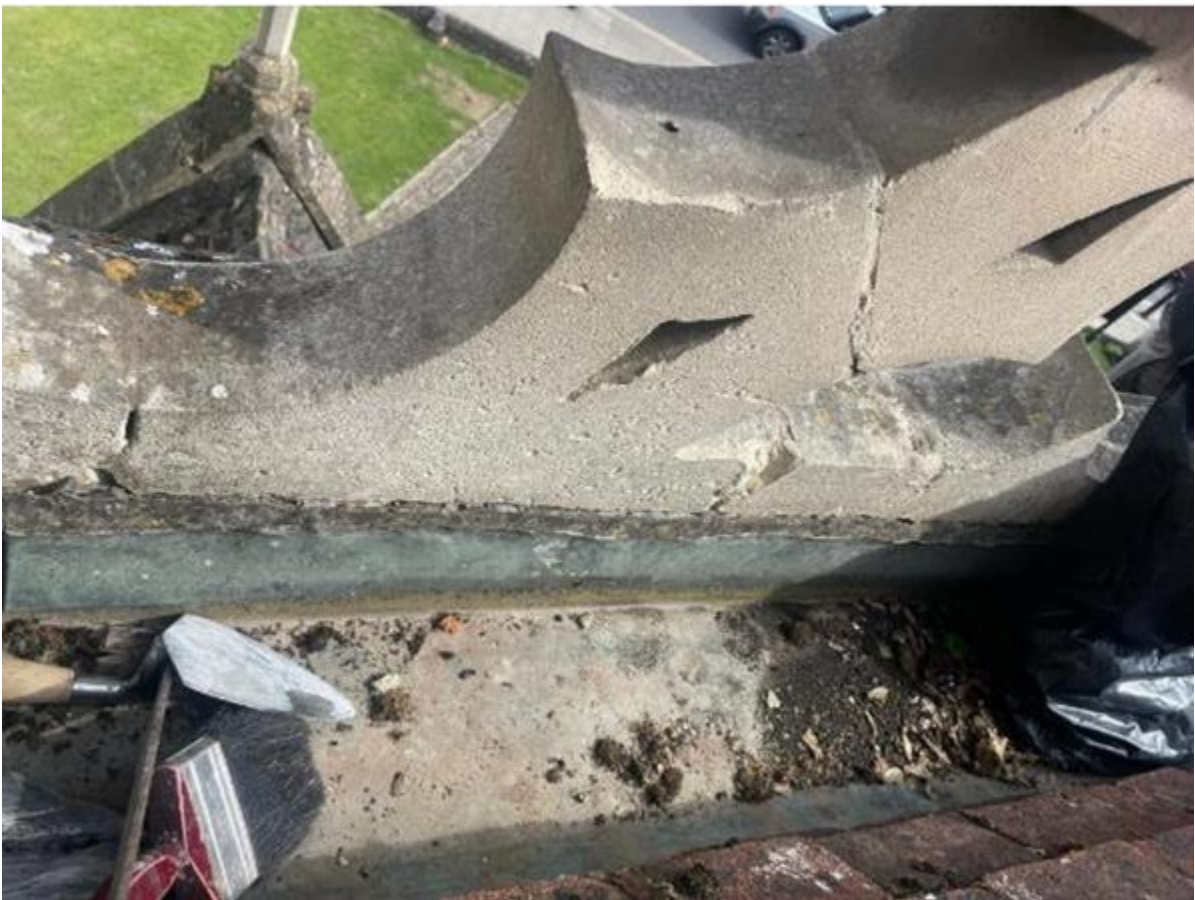
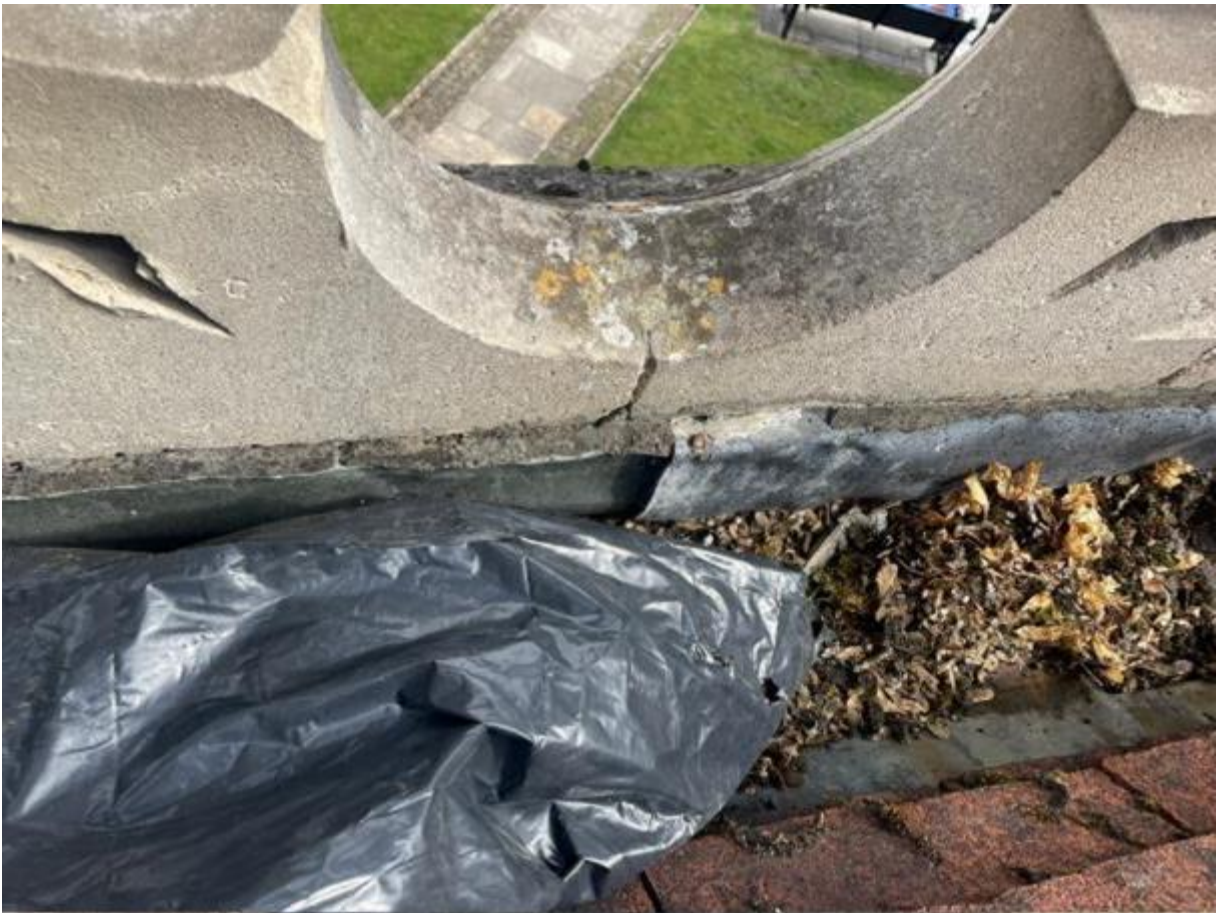
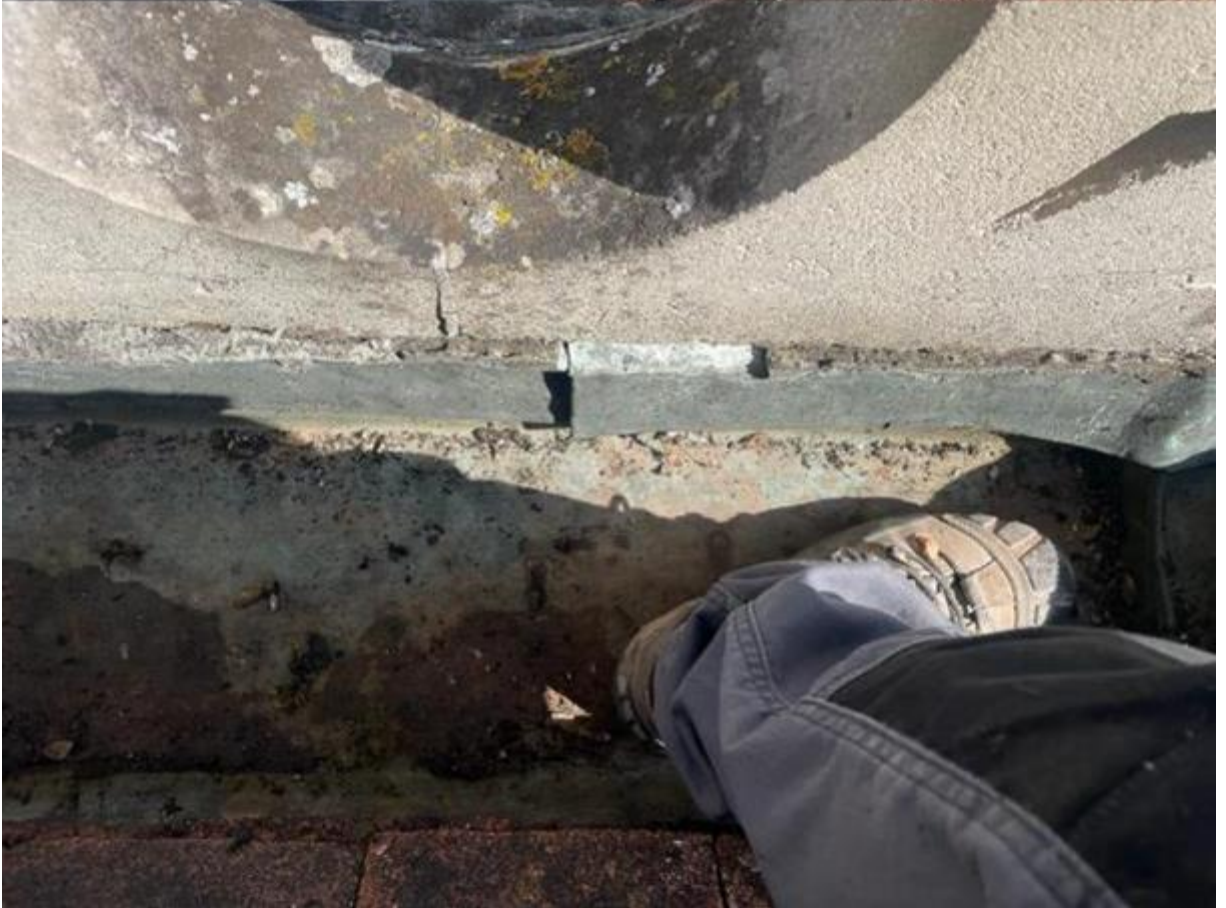
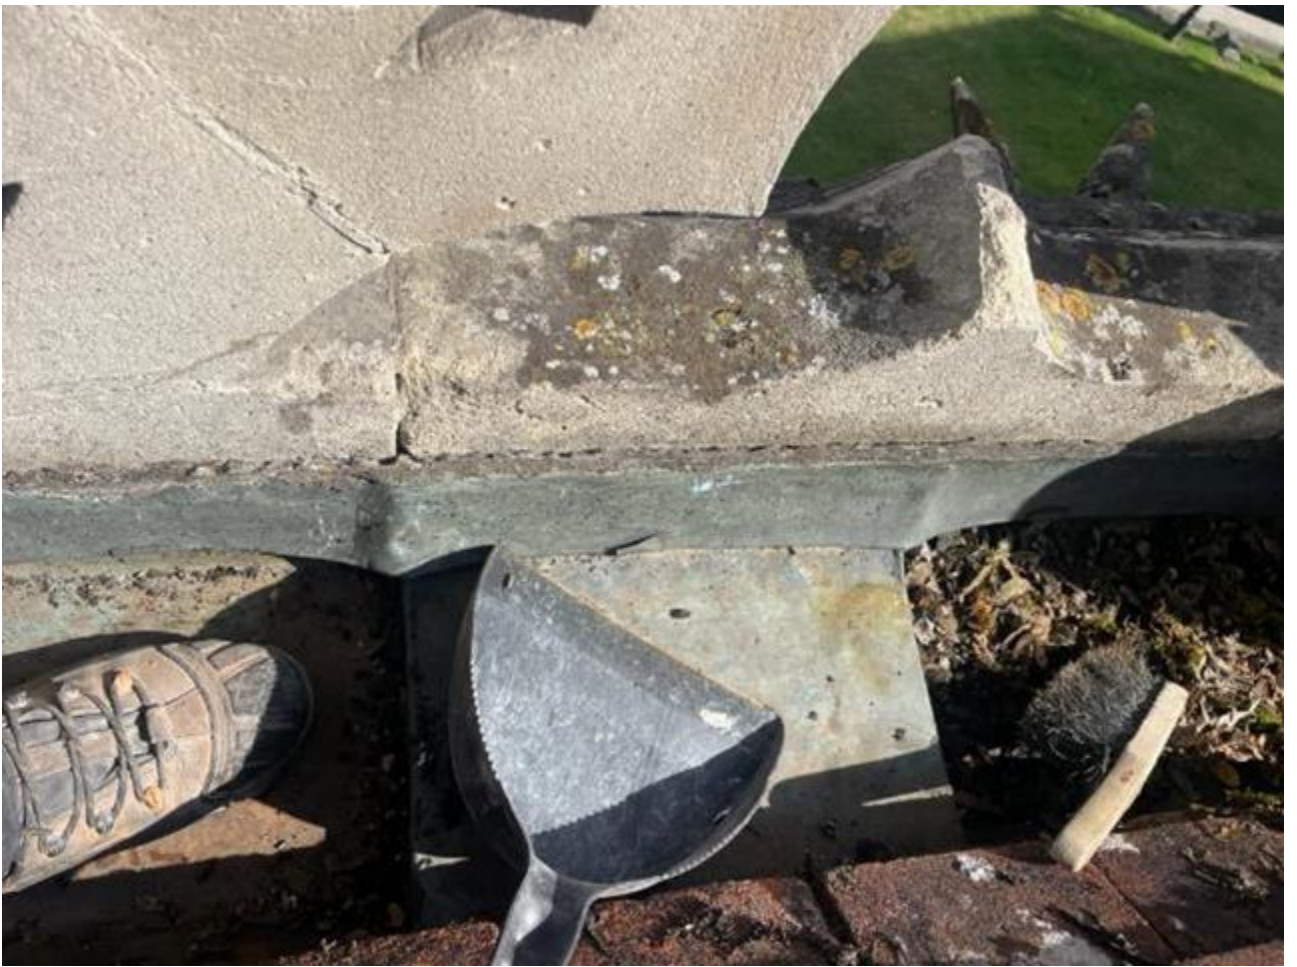
There is no direct access onto the nave roof making a close inspection of the roof coverings not possible. The roof was however partially visible from the tower roof and ground. The following was noted. Both parapet gutters were fairly heavily covered in debris mostly leaves and dead moss. This should be cleared as a matter of urgency. Both roof slopes, but particularly the north slope were heavily covered in moss and organic matter. Several missing tiles were observed to both slopes of the roof pitch. The north pitch tiles showed signs of delamination to areas of the roof this suggesting the tiles covering are coming to the end of their life span: the coverings may well be the original 1850's roof coverings. A closer inspection of the roof coverings by an experienced roofer would be recommended to determine its condition and possible remaining life span. The long-term planning for the recovering of the nave roof would be important due to its likely impact on the finances and operation of the Chapel.

Gutter cleaning
and inspection
