Beam hole Repairs

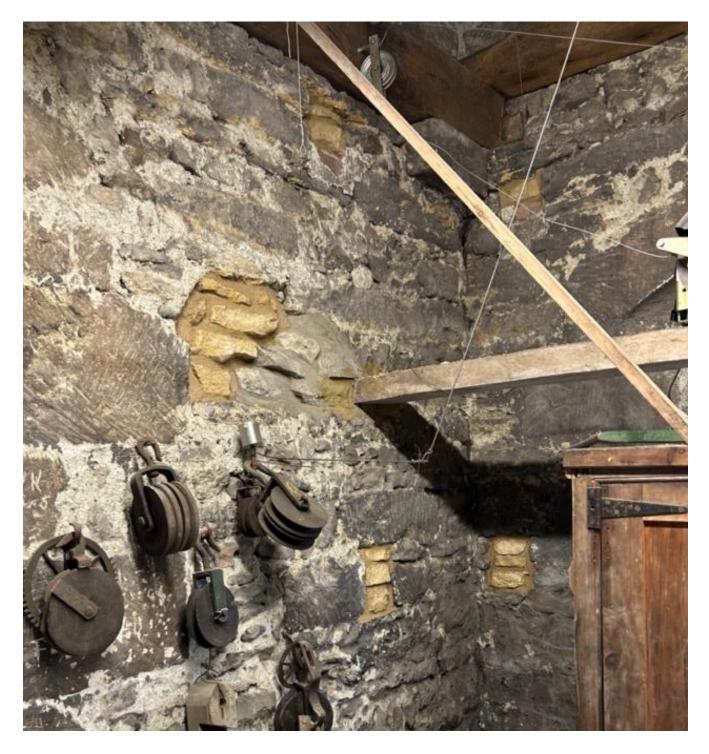
The Chapel tower is the oldest part of the building and dates back to the 13th century. During its 800 year life a significant amount of rebuilding work has been undertaken. This involved changes to the structure, floor, ceiling, bell framework and roof heights. These changes have created a large number of open beam holes.

Whilst inspecting the damage to the Clock room floor and the panelled ceiling Andrew Waring (Structural engineer) highlighted that over time the exposed beam holes would structurally weaken the tower. He recommended filling them in.

Supported by the Warminster Town Council Community Infrastructure Levy (CIL) grant the Moulding's Stone Masons have filled 39 beam holes and undertaken additional repointing if stonework and beam ends. This work included several specially cut pieces of stone for the spiral stair case.
