St Lawrence Chapel Warminster East Window Repairs May to August 2023

Warminster, St Lawrence Chapel

East Window, Pre-restoration

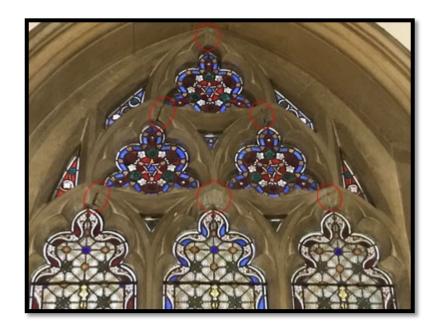
It has been noted that some of the stonework joints within the tracery of the window would benefit from being pinned to ensure that they remain in position.

We would offer a cost of £317.00 excluding VAT to pin the six joints that have been identified, using stainless steel pins and stone epoxy resin to ensure there is no slipping of the joint. The joints to be finished with a lime based mortar to prevent water ingress.

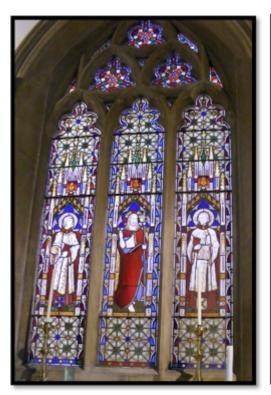
A 19th century (1855) stained glass window comprising of 3 no main lights 3 no tracery panels and 4 no squints. The window depicts, St Stephen, Christ in Glory and St Lawrence, set within canopy work. The maker of this window is not as yet known.

The glazing of this window is found in a generally very poor condition, the lead work being very weak, coupled with loss of ties on the saddle bars. This has become known following recent works to carry out insitu repairs to a small number of broken sections of stained glass. Considerable care was required to ensure that the glazing was not pushed apart while this work was being carried out.

Removal of this glazing for re-leading should be considered as a priority, to ensure the security of this window.

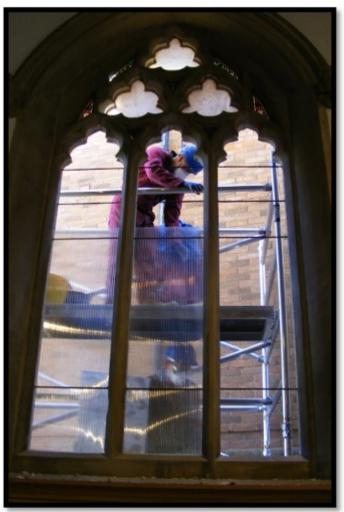
Removal of the glazing from the stonework

All glazing panels were removed <u>from the stonework</u>, to the workshop. Rubbings of each panel taken and marked with CVMA <u>notations</u>, photographs of each panel taken on the light box prior to de-glazing. Wire guards take down and put aside for later re-instatement.

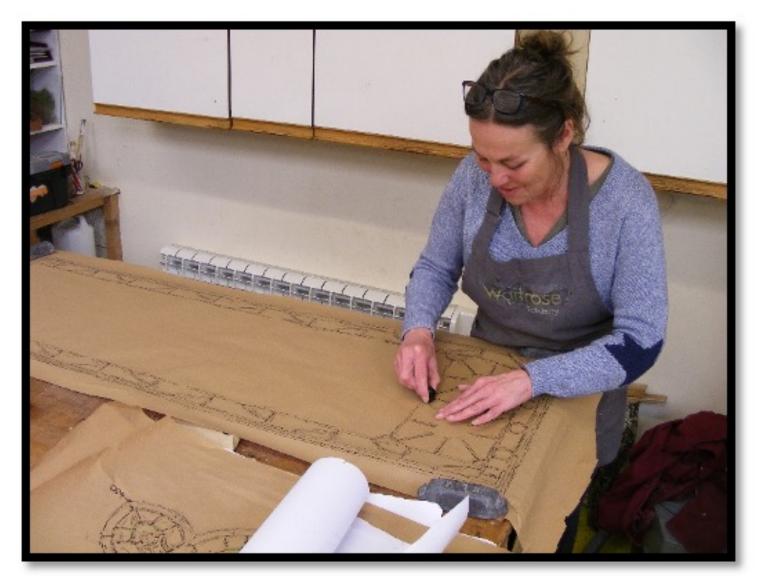
Taking rubbing of the panels prior to de-glazing

There is some movement in the tracery stonework that will require pinning to stabilise.

Those areas of movement in the tracery stonework were drilled and pinned using non-ferrous bar, to stabilise.

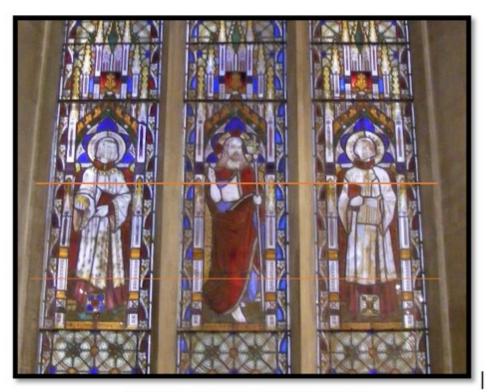
It was noted on removal that there were insufficient support bars to the figurative elements, these would appear to have been removed at some point and coper ties cut off. This is one of the factors that has contributed to the general condition of the glazing, allowing more movement to take place in these areas, the lead work to the figures being weakened to the point, that strong wind or a light impact could easily have resulted in the glazing failing.

Bars have been removed from the figures

Extra bars have been provided in those areas on the figurative element, where they had previously been removed.

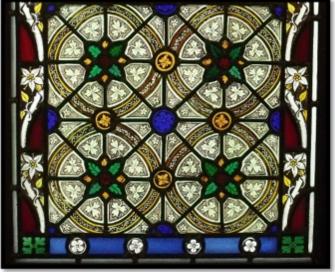
The glass was found to be in a well fired stable condition, with only the leadwork being of real concern. The artist responsible for this window has not been identified, but close inspection of the painted detail reveals someone of considerable talent, especially in the areas of grisaille detail that forms the background to the figures.

Fine qualities of painted detail

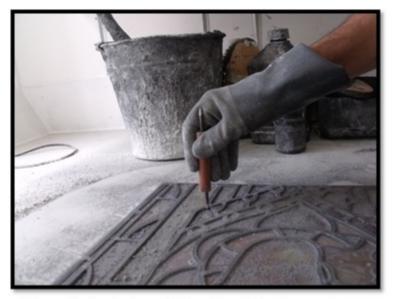
Waterproofing the glazing, application, drying, picking to remove the excess

All the lights have been re-leaded in a new lead calm of the same visible profile as the original, the completed lights being waterproofed with traditional lead light cement and new copper wire ties soldered to the internal lead work joint to allow fixing to the saddle bars.

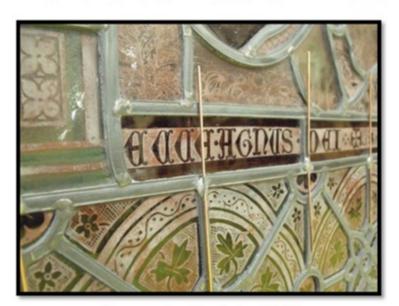
New copper ties solder to lead work joints.

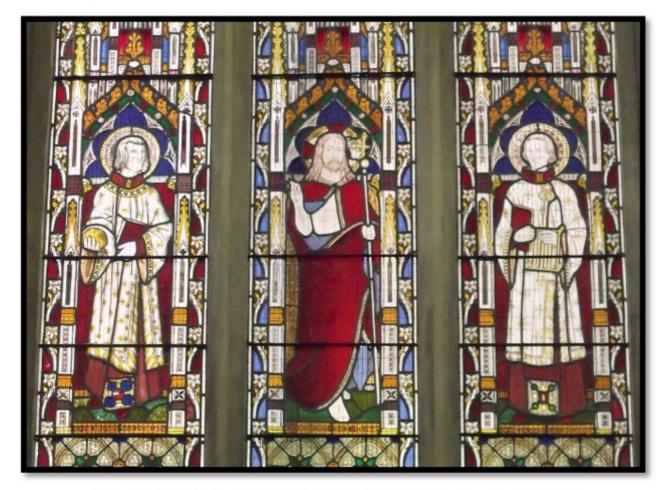
Introduction of two extra bars for each figure, to ensure proper support.

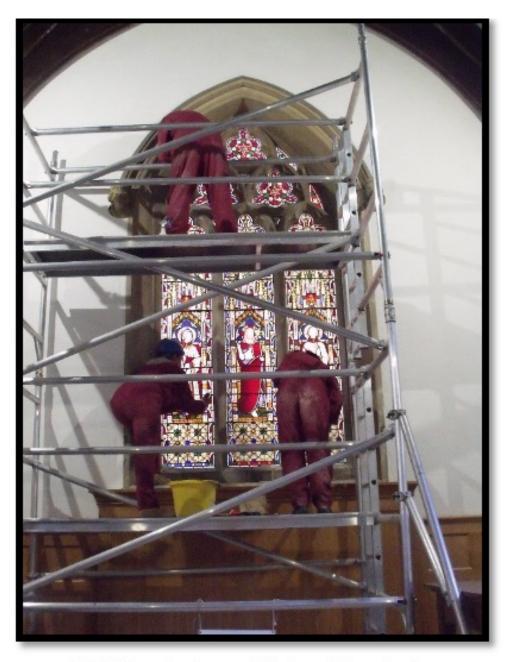
Finishing the internal fixing of the glazing

All was returned to the church and fixed back into the stonework and finished with a lime-based mortar, incorporating new non-ferrous saddle bars painted black.

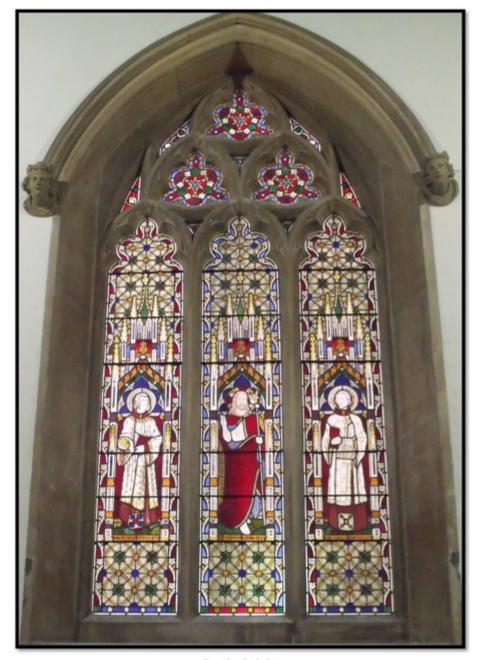
Completed window.
