The Chapel of St. Lawrence Warminster

Condition Inspection Report 2023

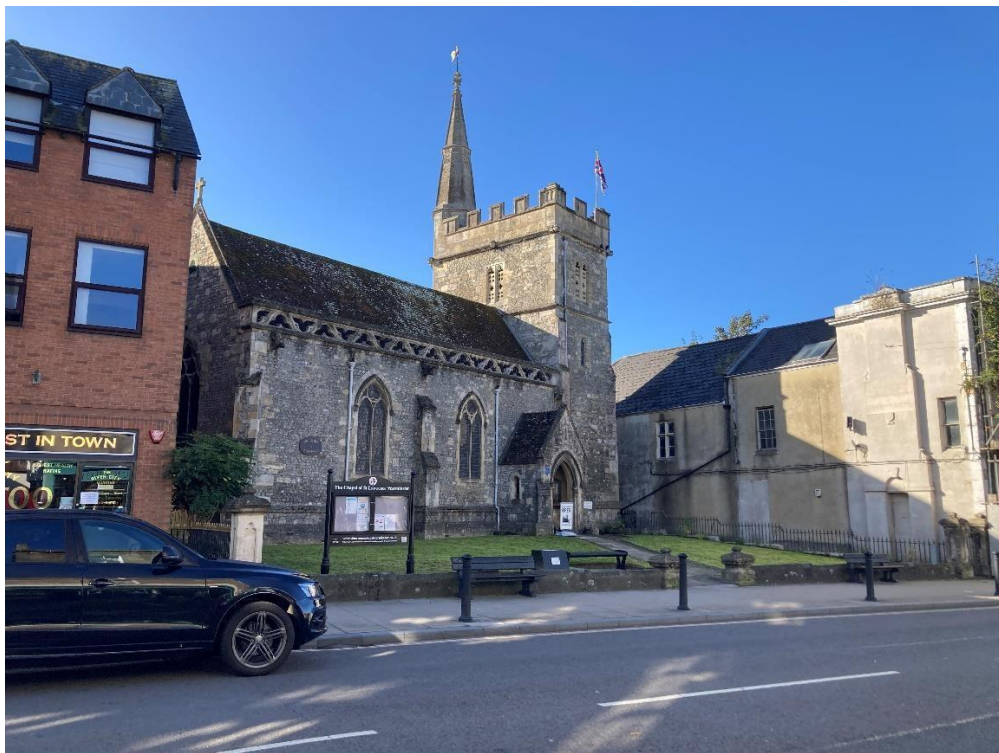
Based on a survey carried out on 17th January 2023

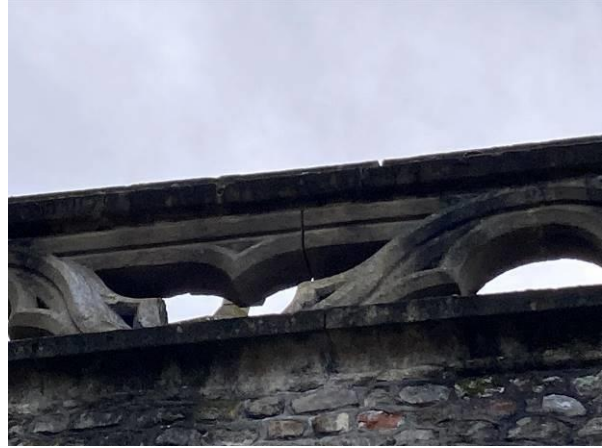
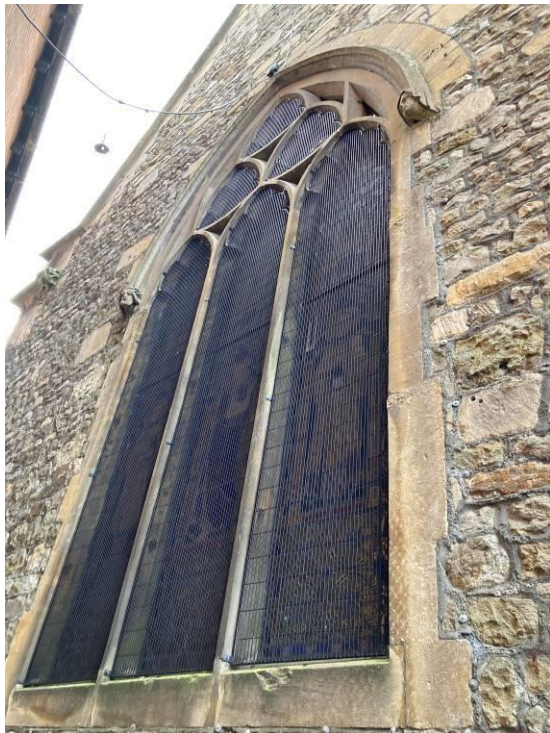
East Window – mesh fixings /cracking to stone sill.

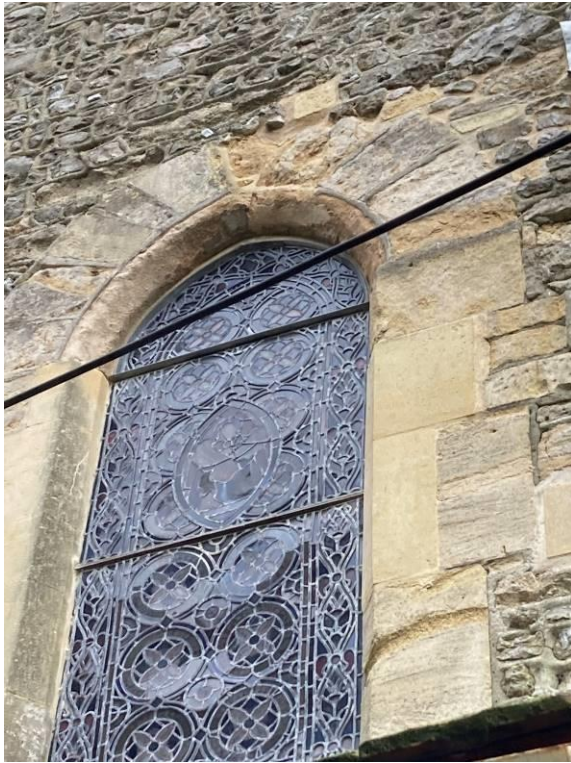
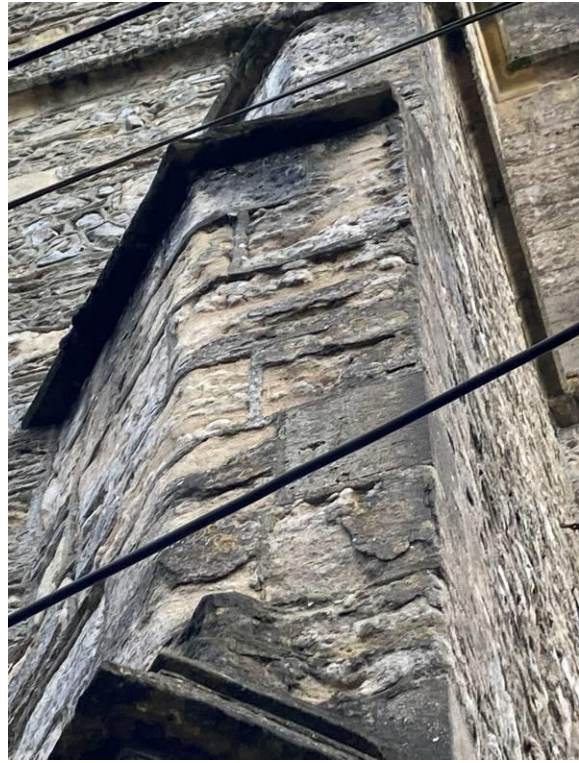
West elevation – lower window and buttress – note hard protruding mortar.

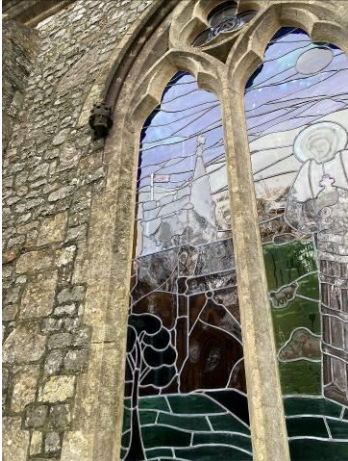
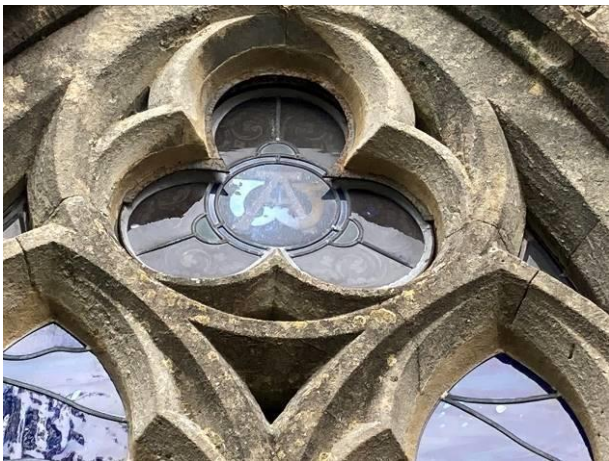
Nave north east window tracery condition.

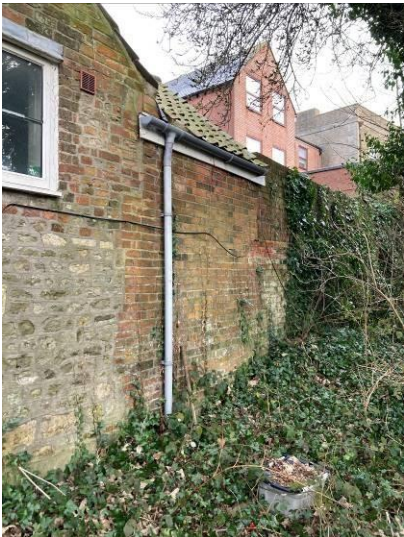
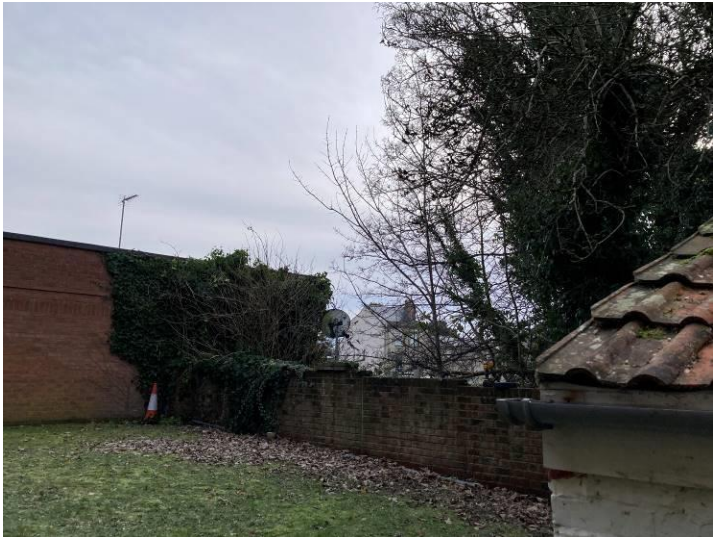
Southern boundary wall

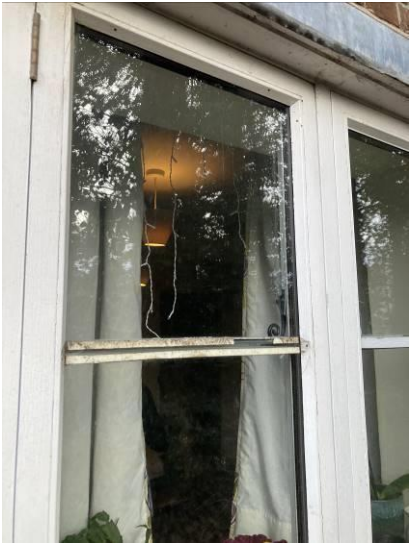
Curfew Cottage—south elevation

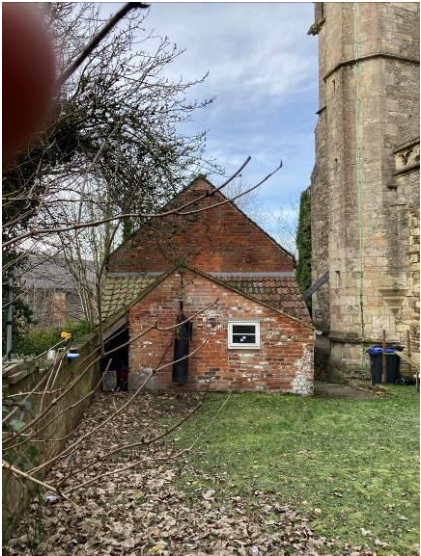
Curfew Cottage - crack to east elevation

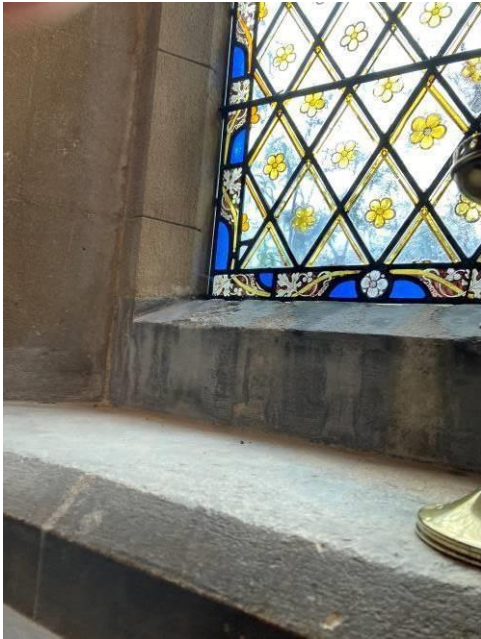
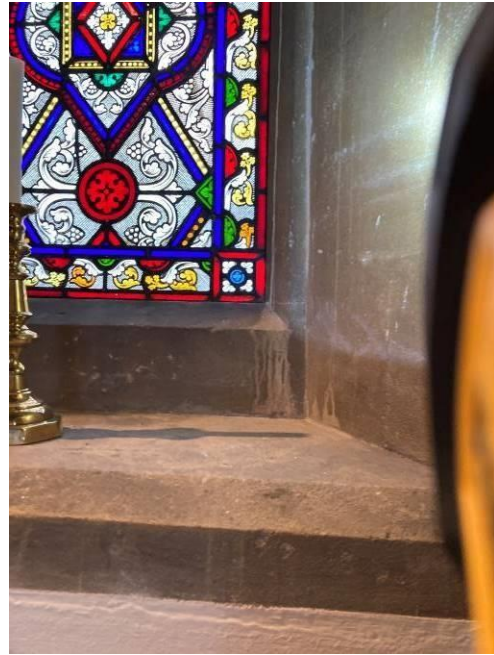
Staining to stone work to nave window sills.

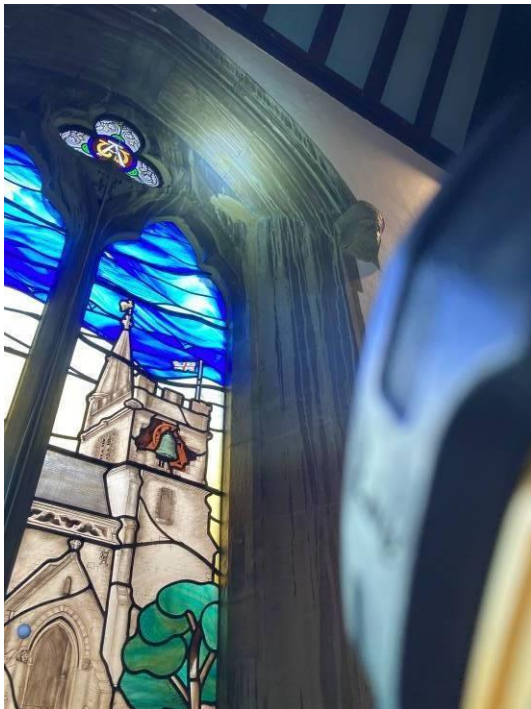
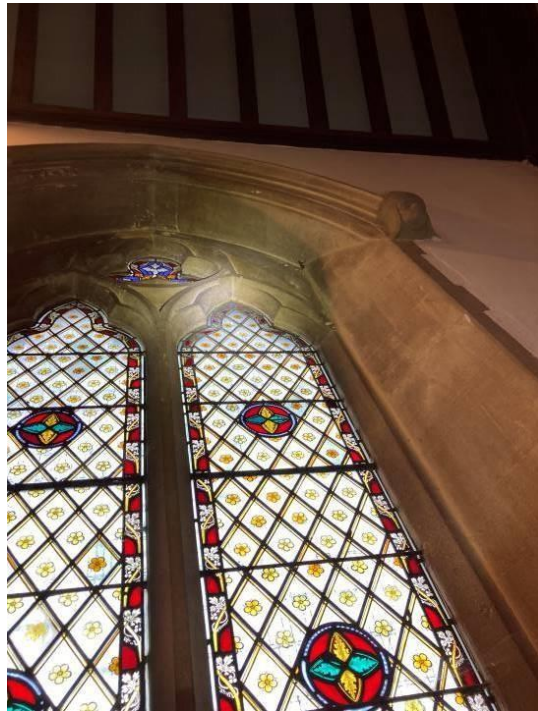
Staining and mortar repairs to nave windows.

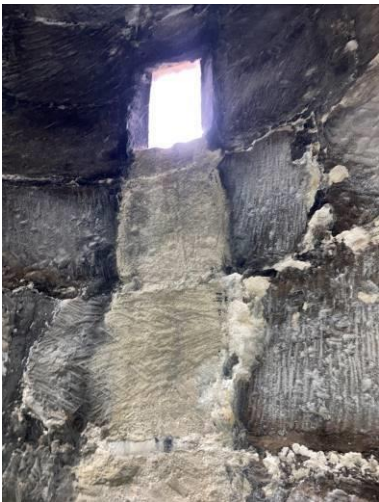
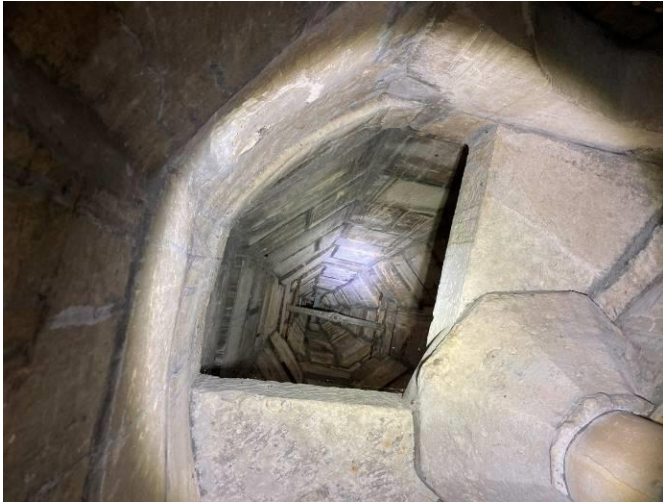
Turret spiral stairwell: staining to windows and opening to Spirelet.

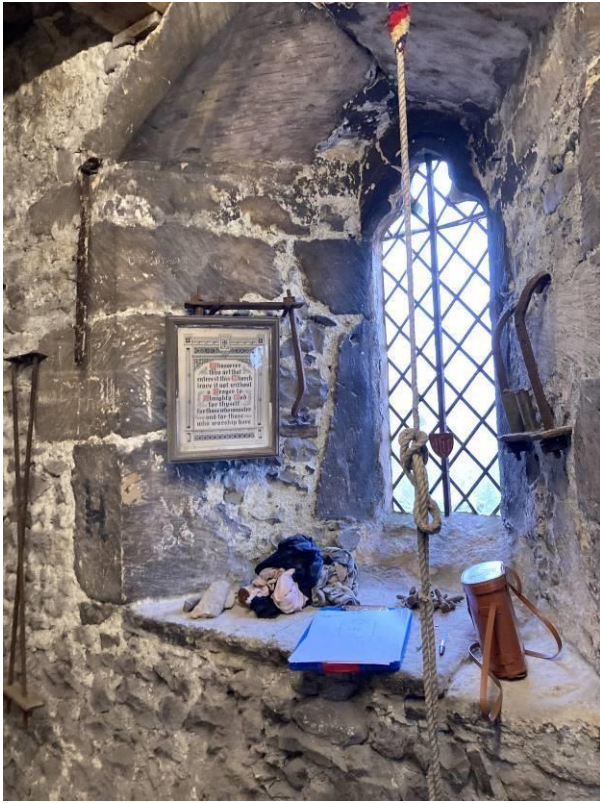
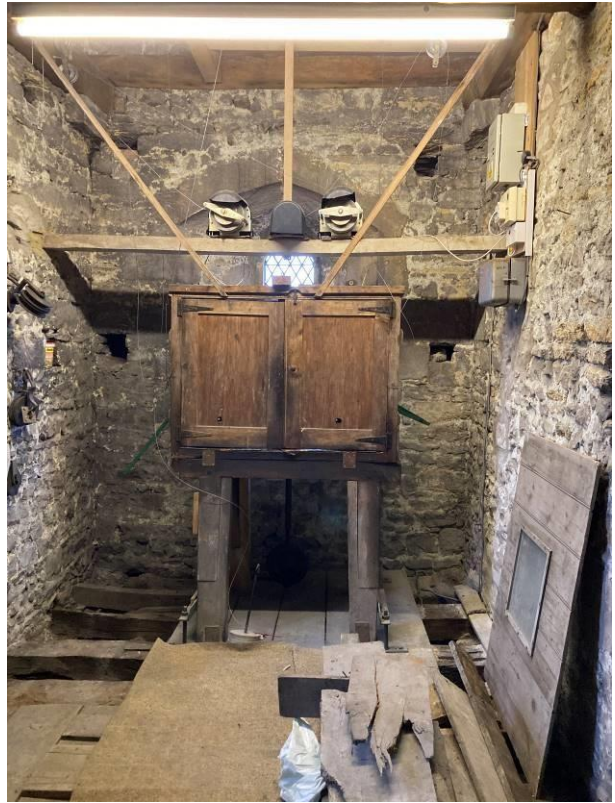
Clock (intermediate) Chamber – note electric units to wall.

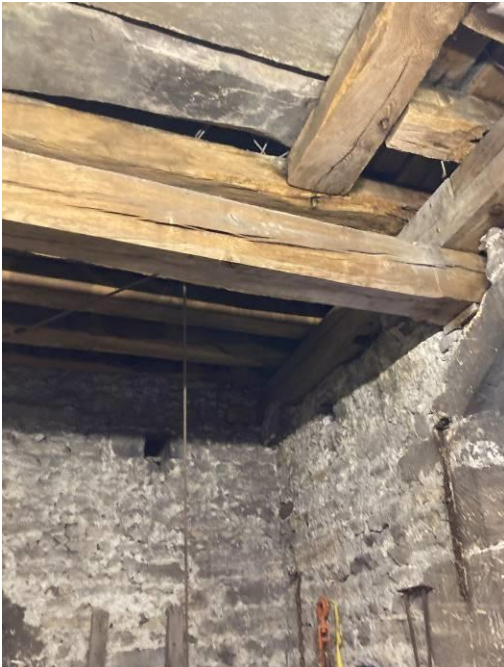
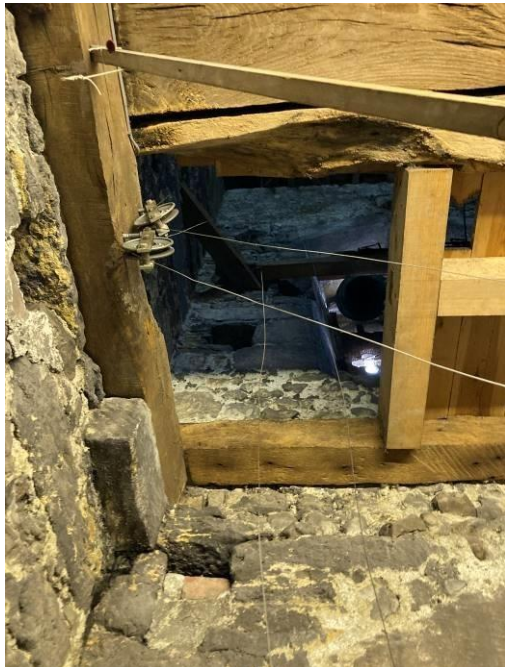
Floor to Belfry showing condition and e opening to southwest corner.

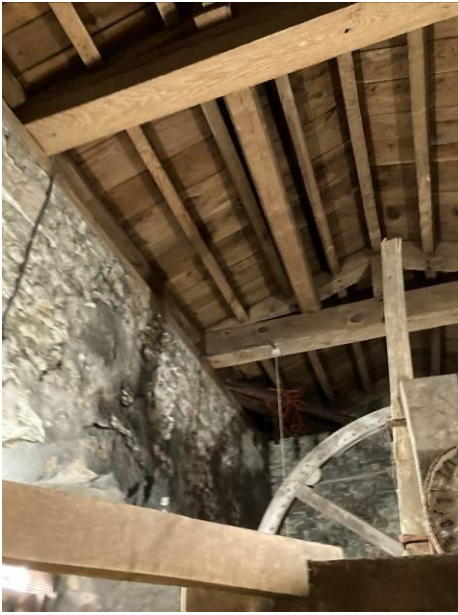
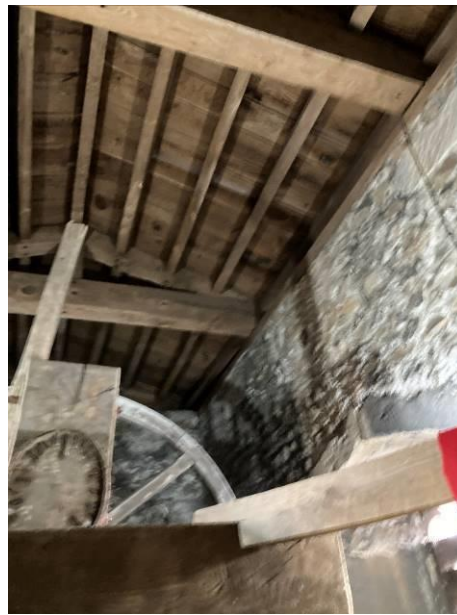
Belfry looking north at bell frame and tower roof.

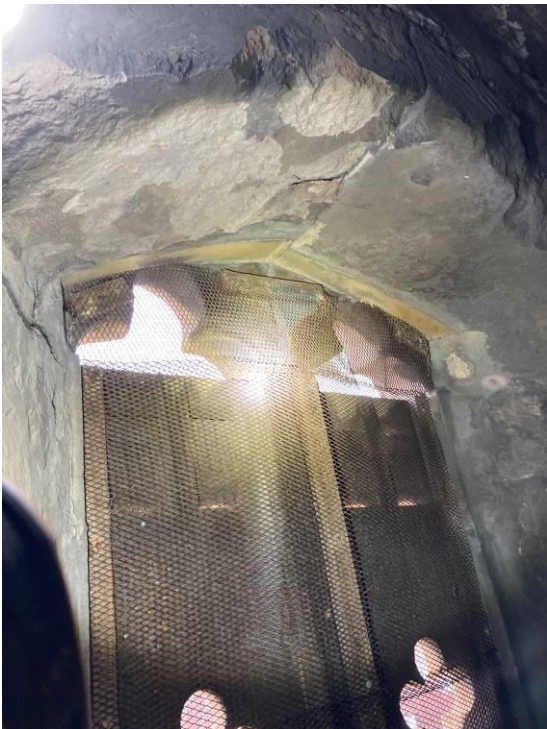
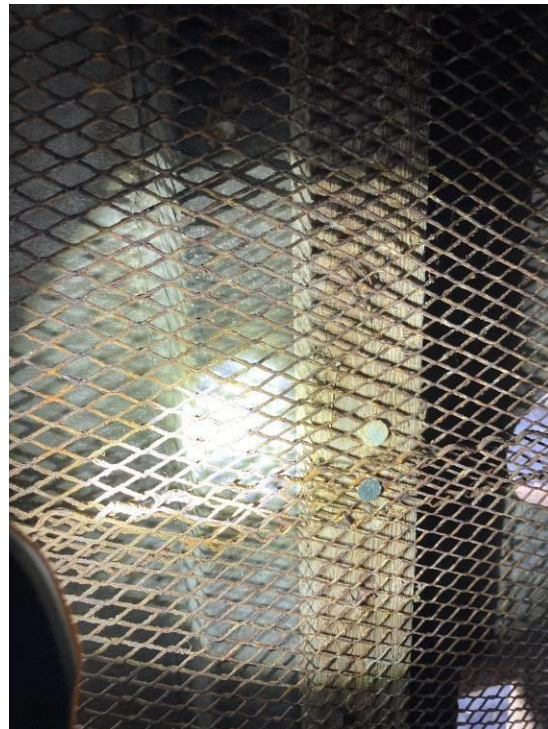
Belfry – west opening with crack and bird mesh – close up of fixings.

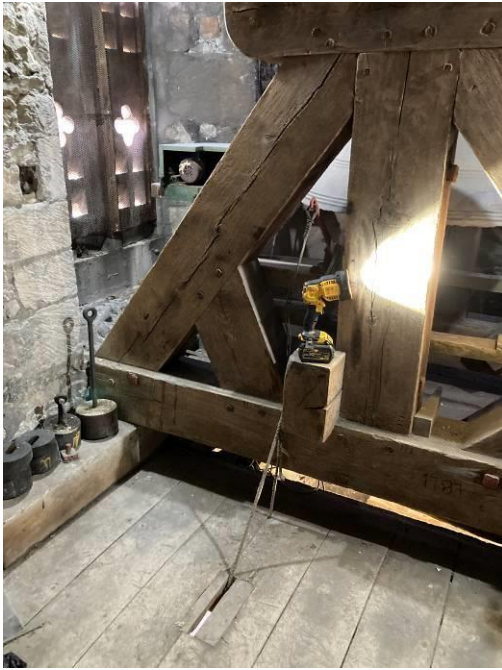
Belfry: bell frame and straps.
