St Lawrence Chapel Warminster

Nave roof inspection and cleaning of the gutters

Nave roof inspection and cleaning of the gutters 6th July 2023

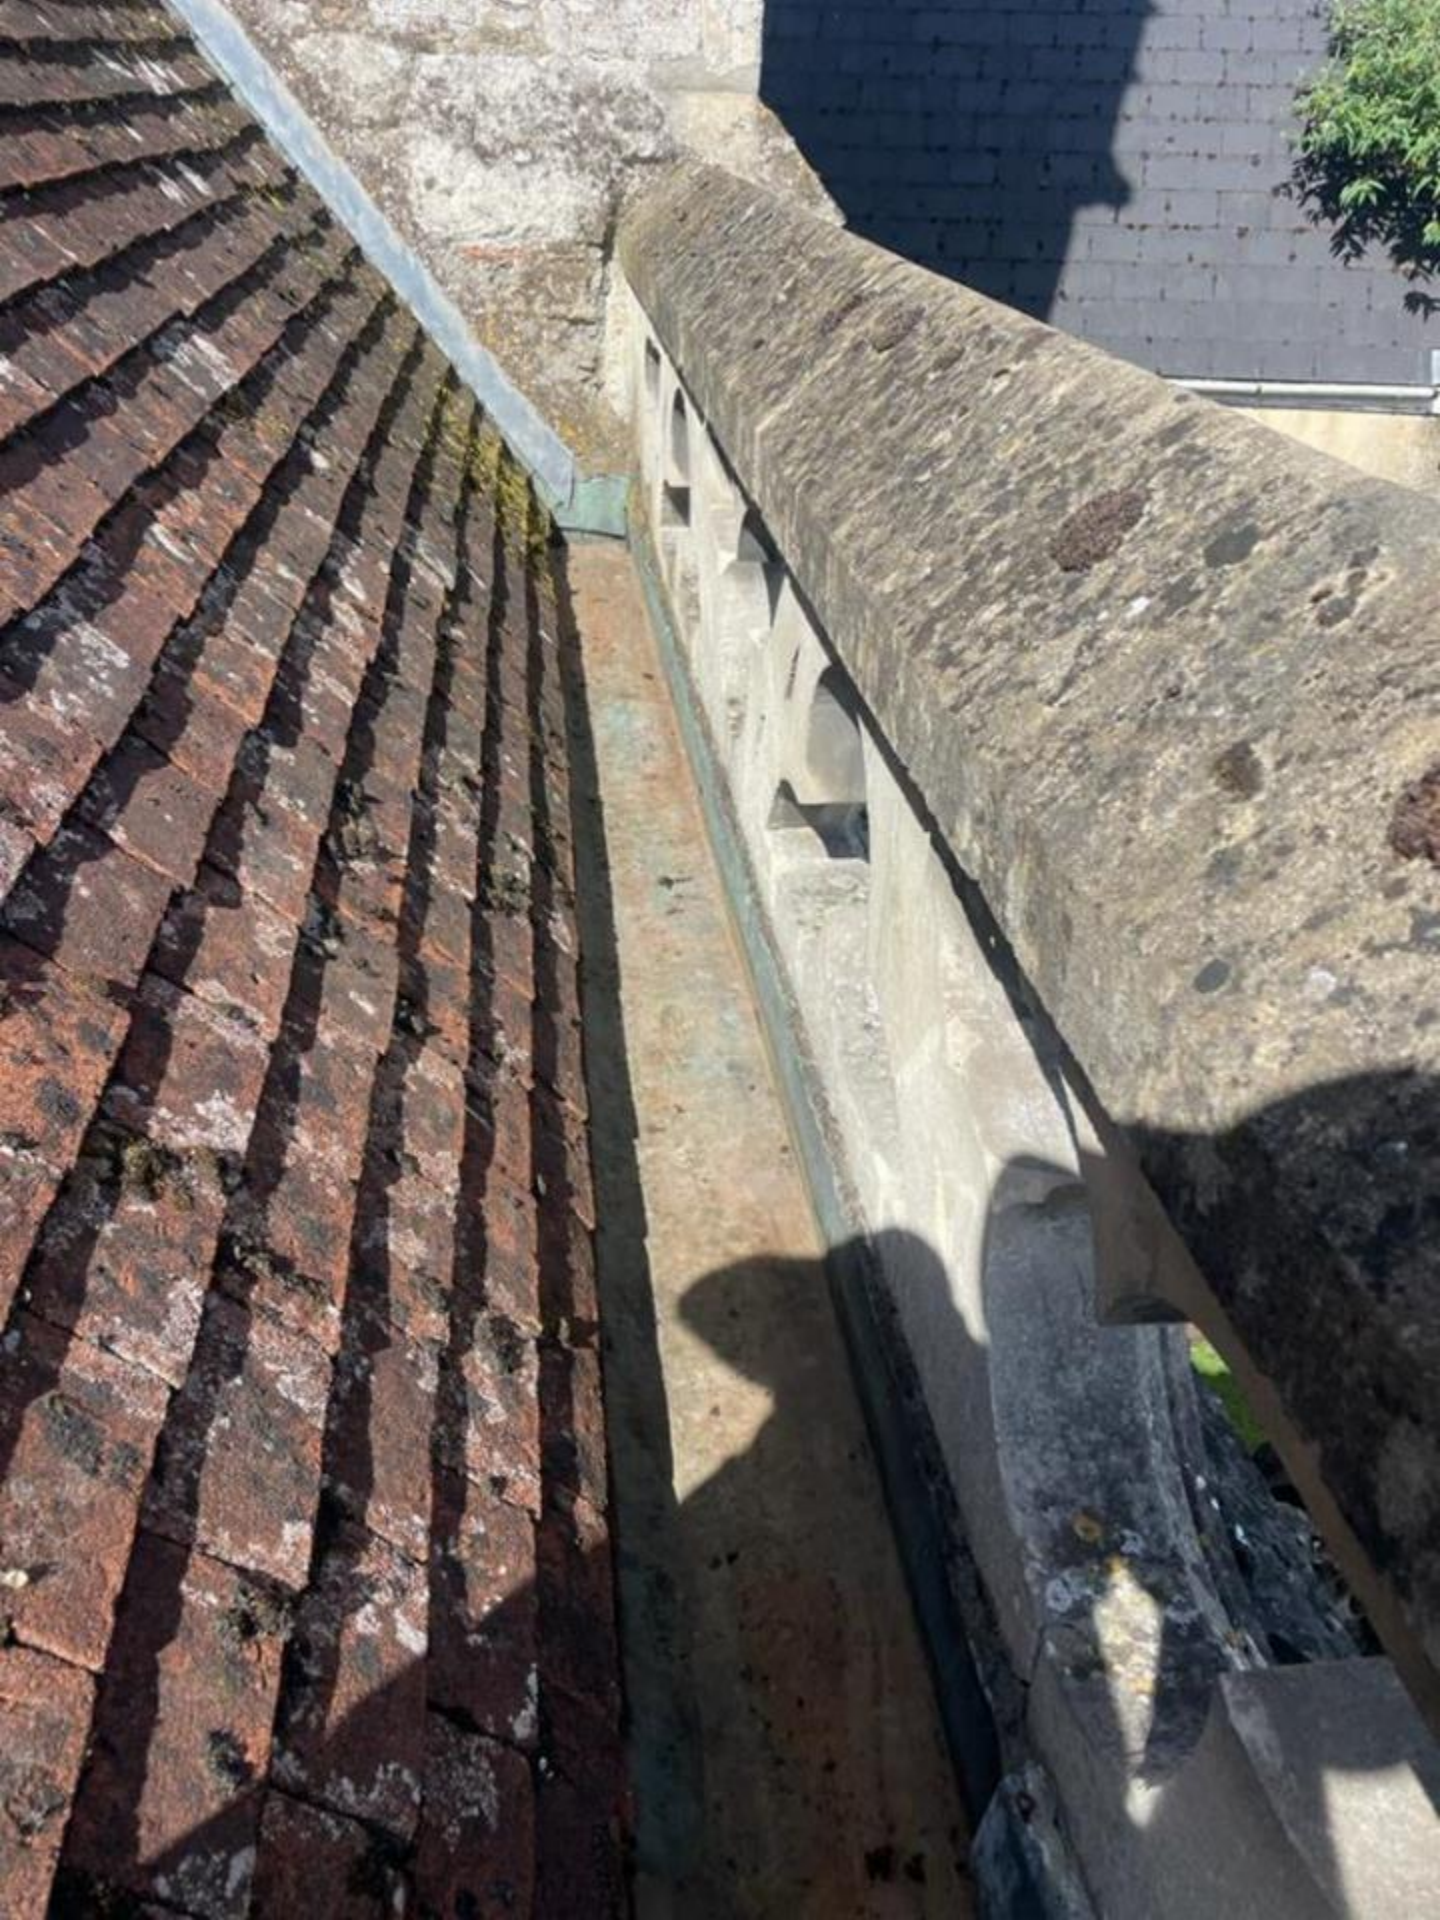
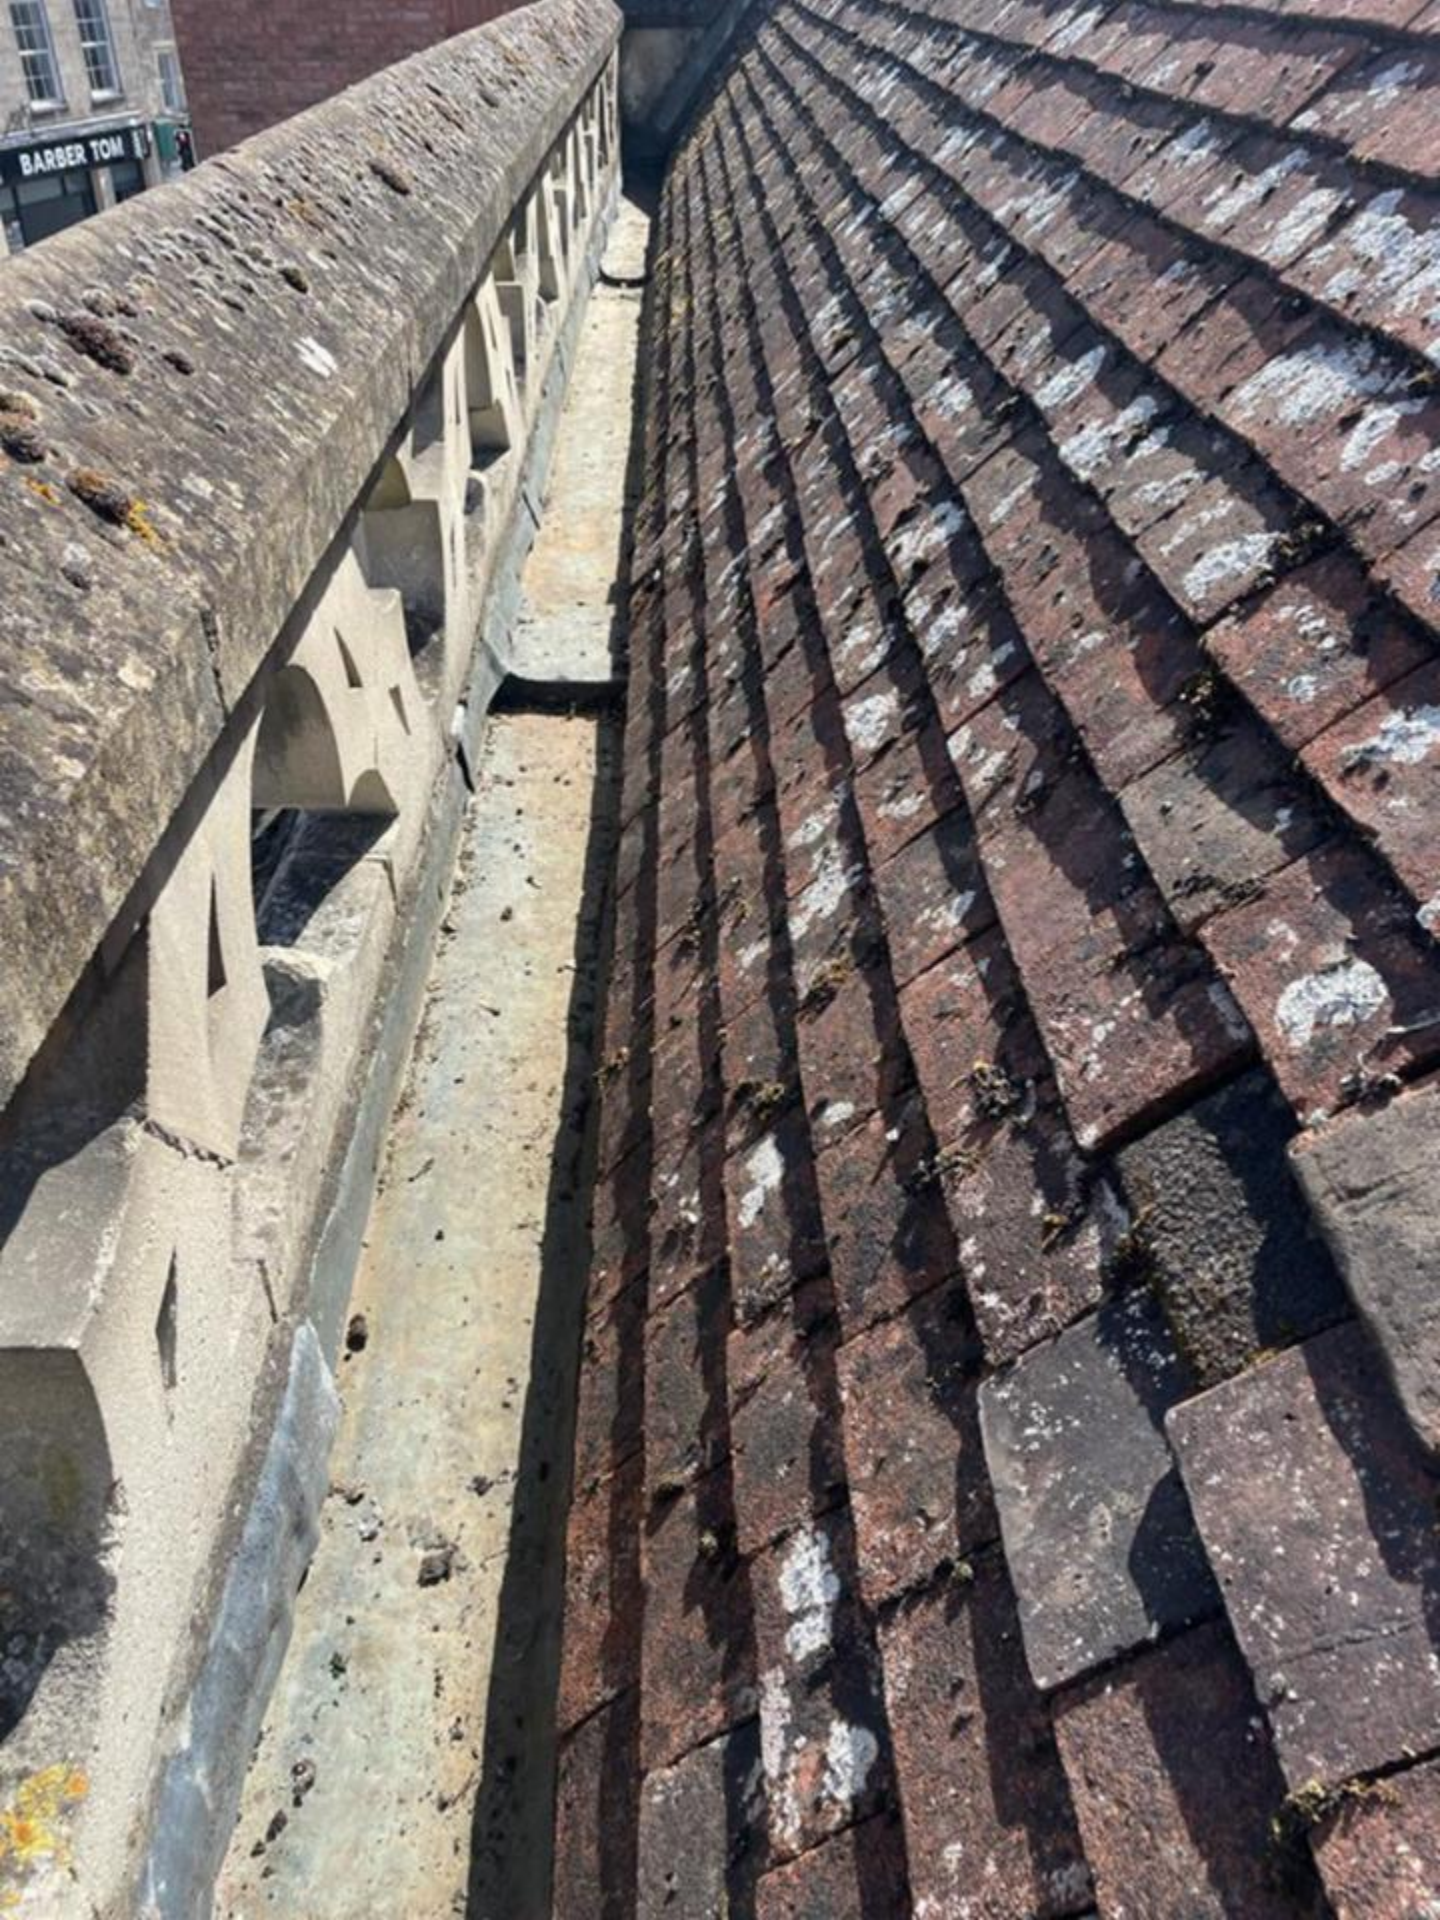
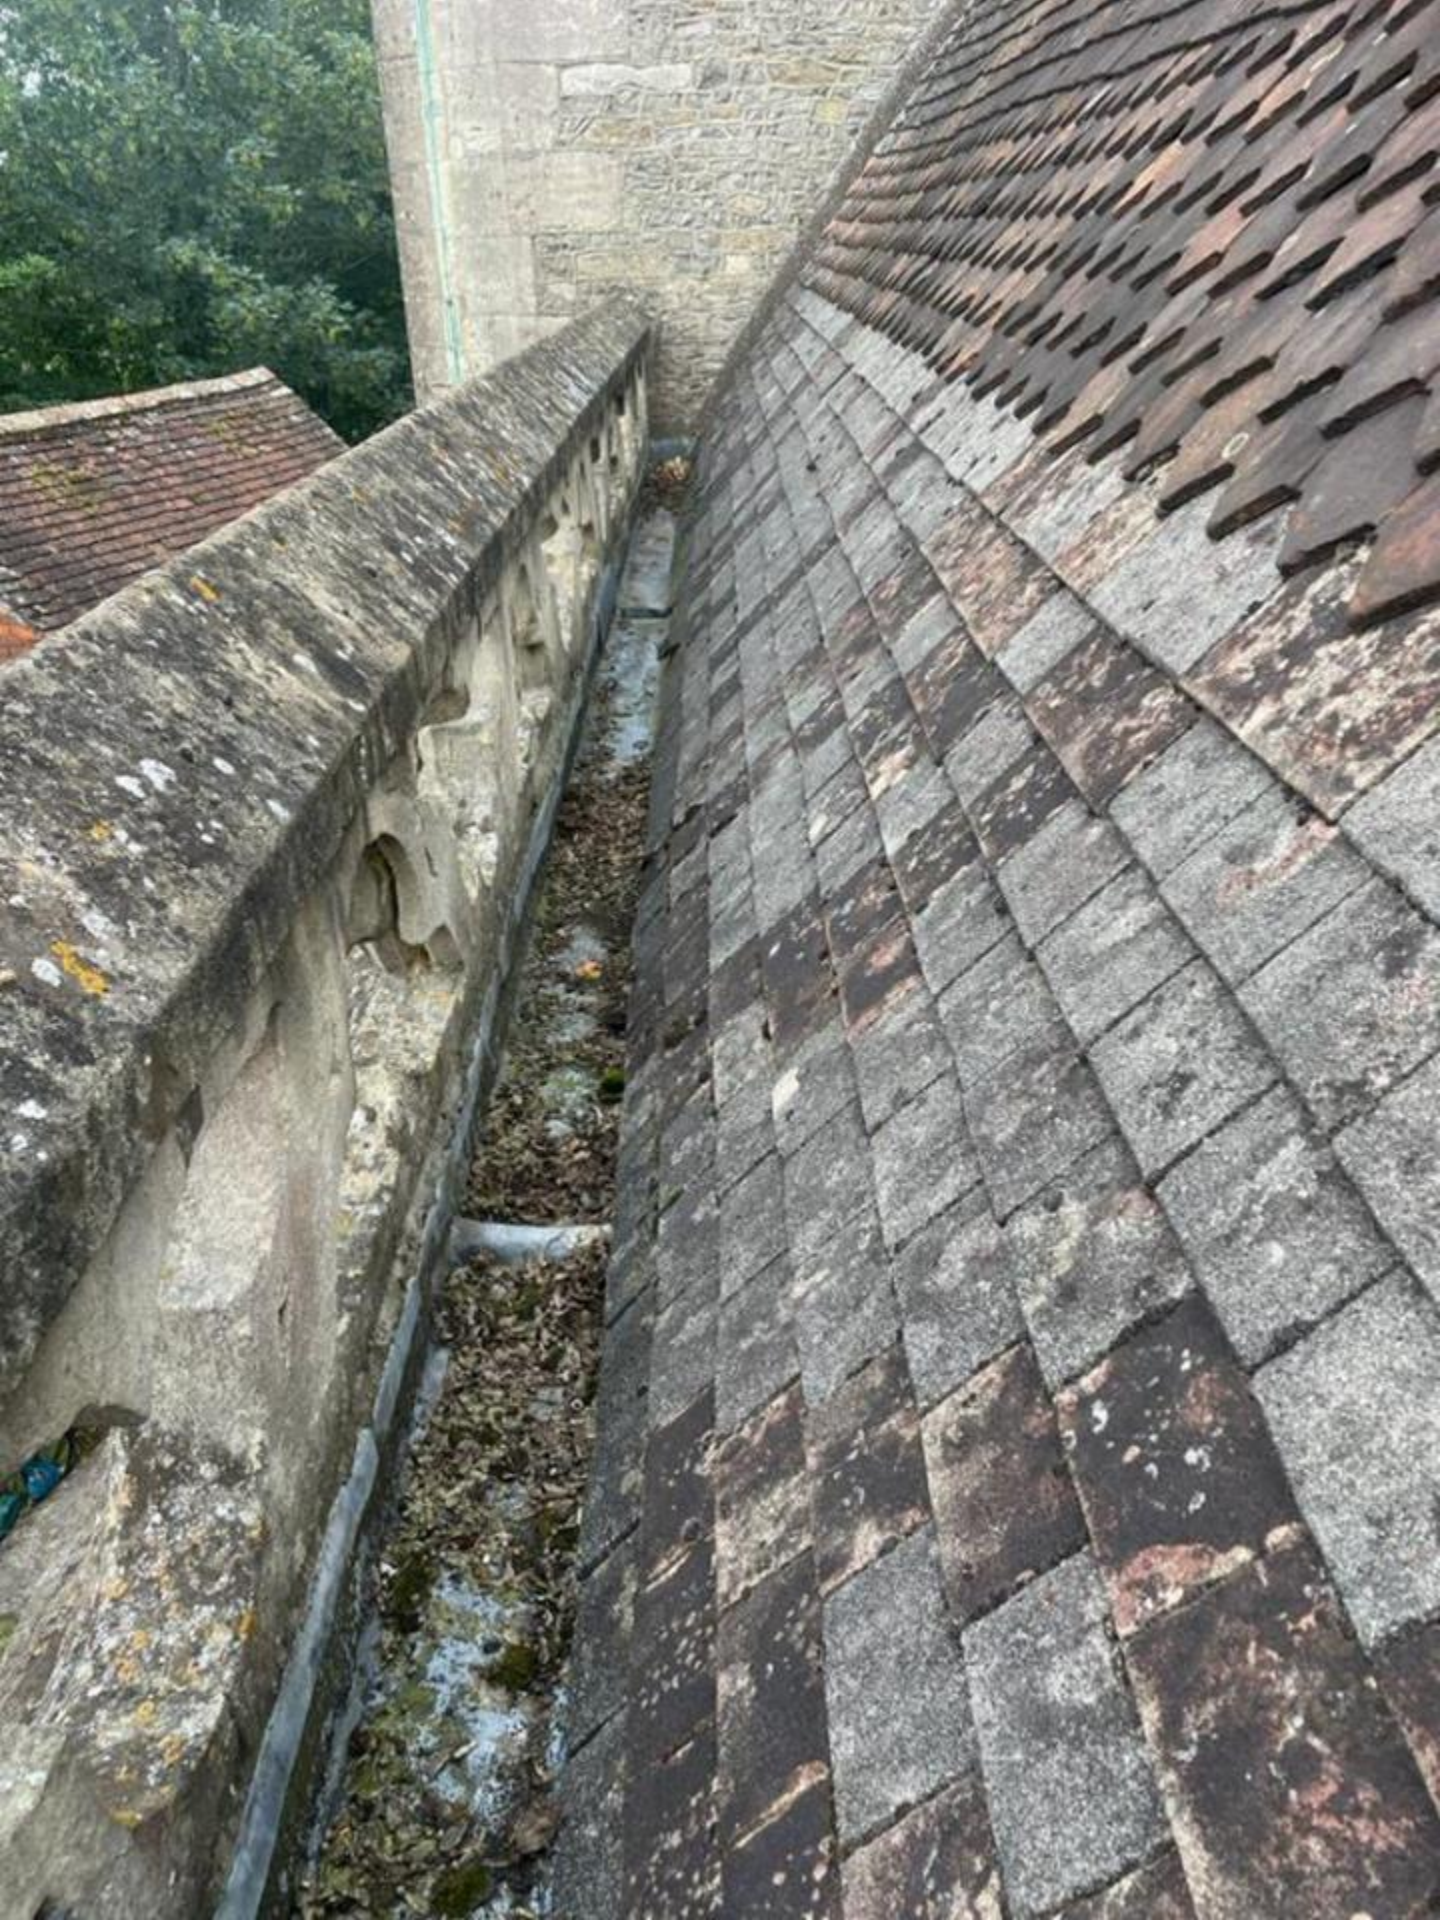
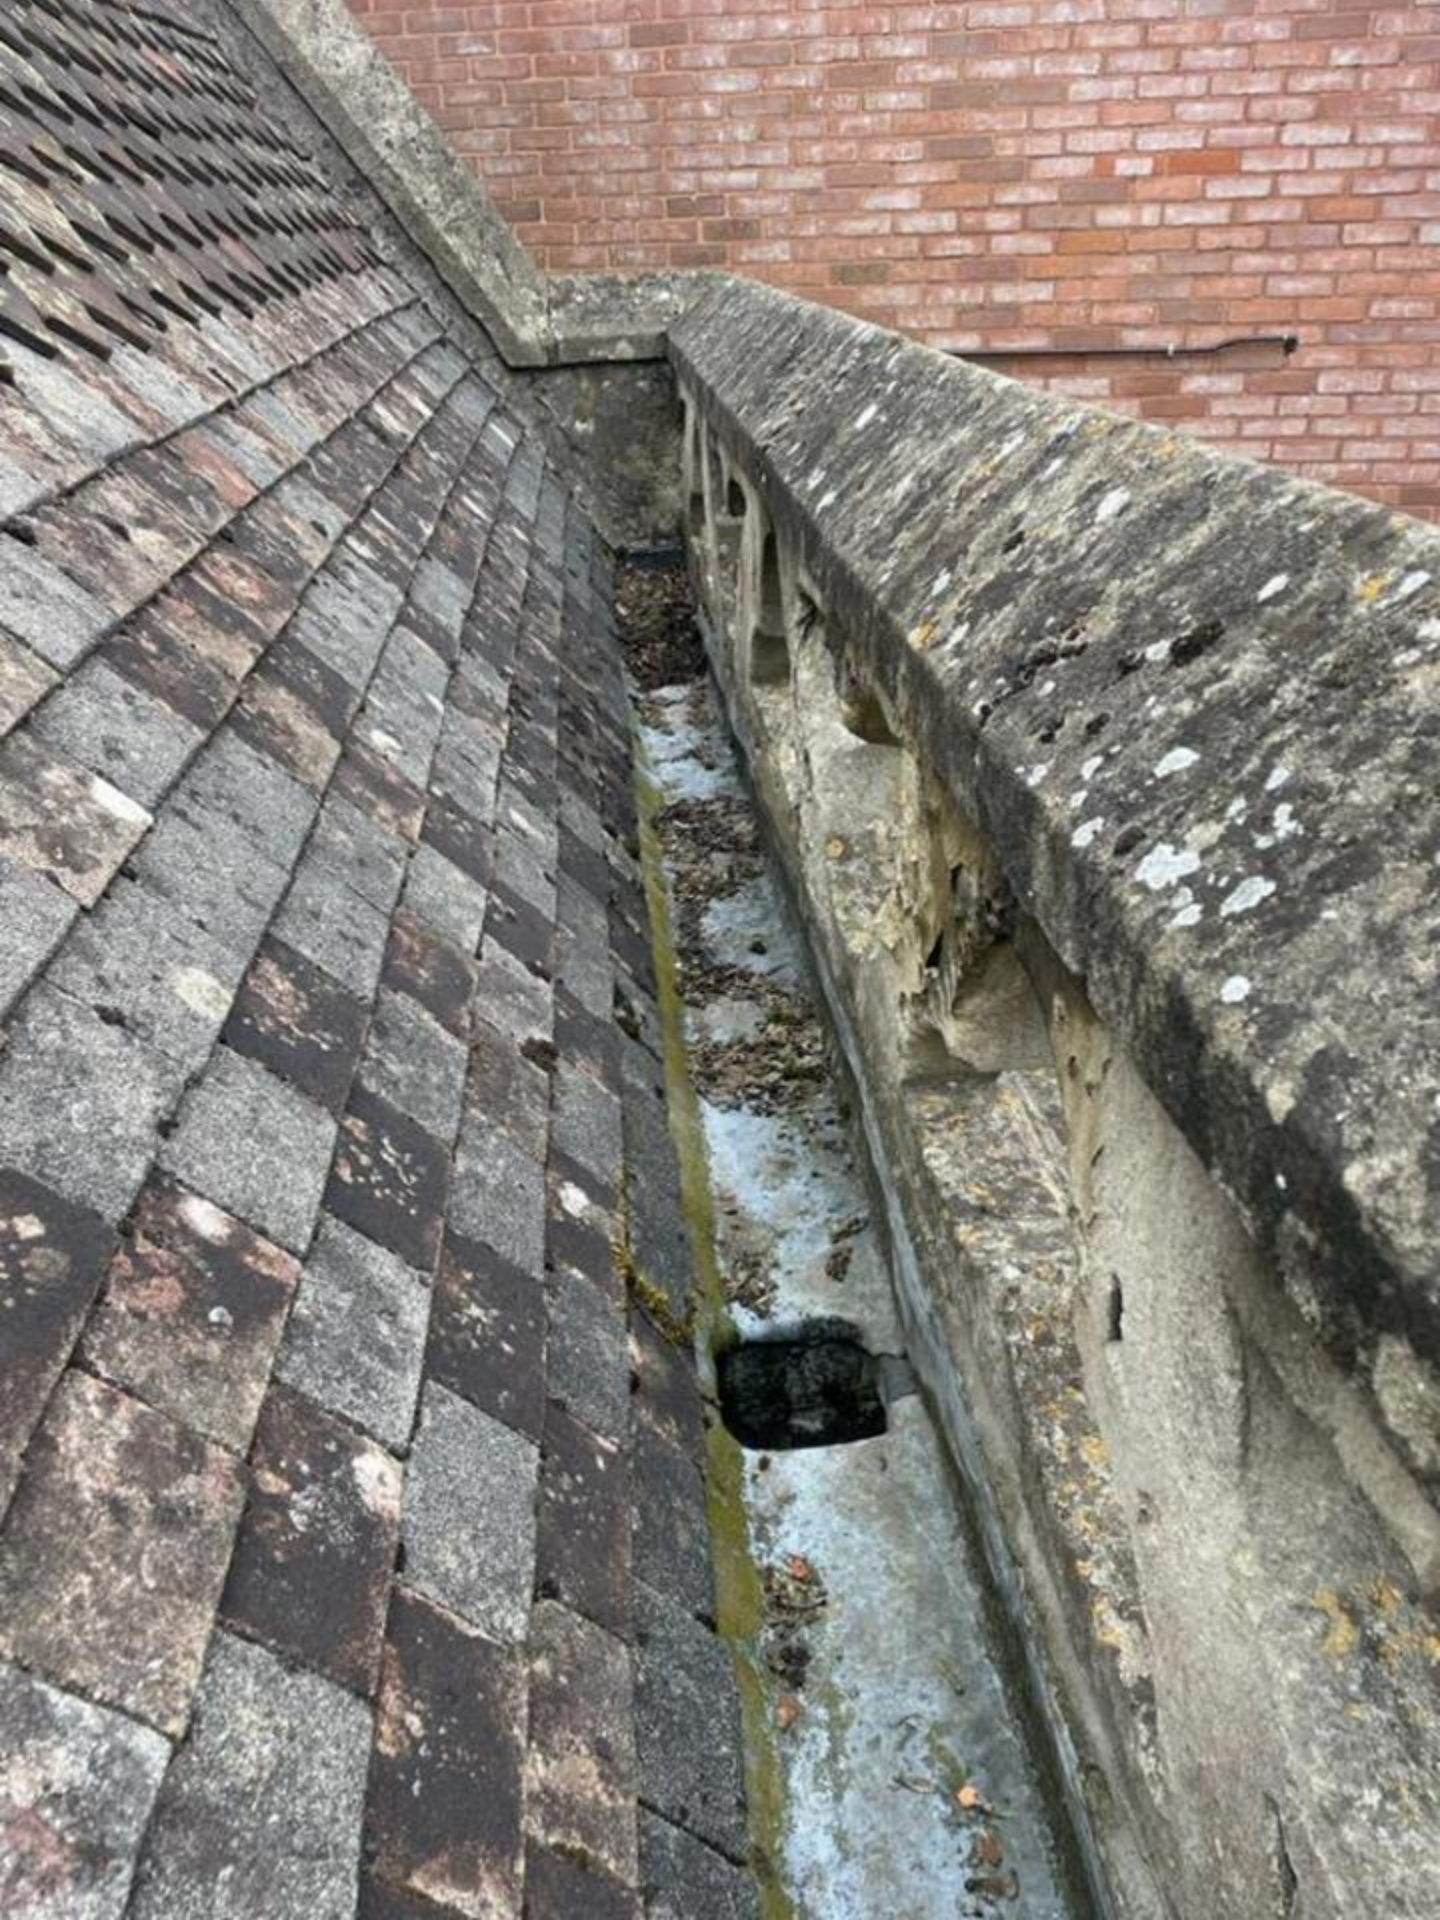
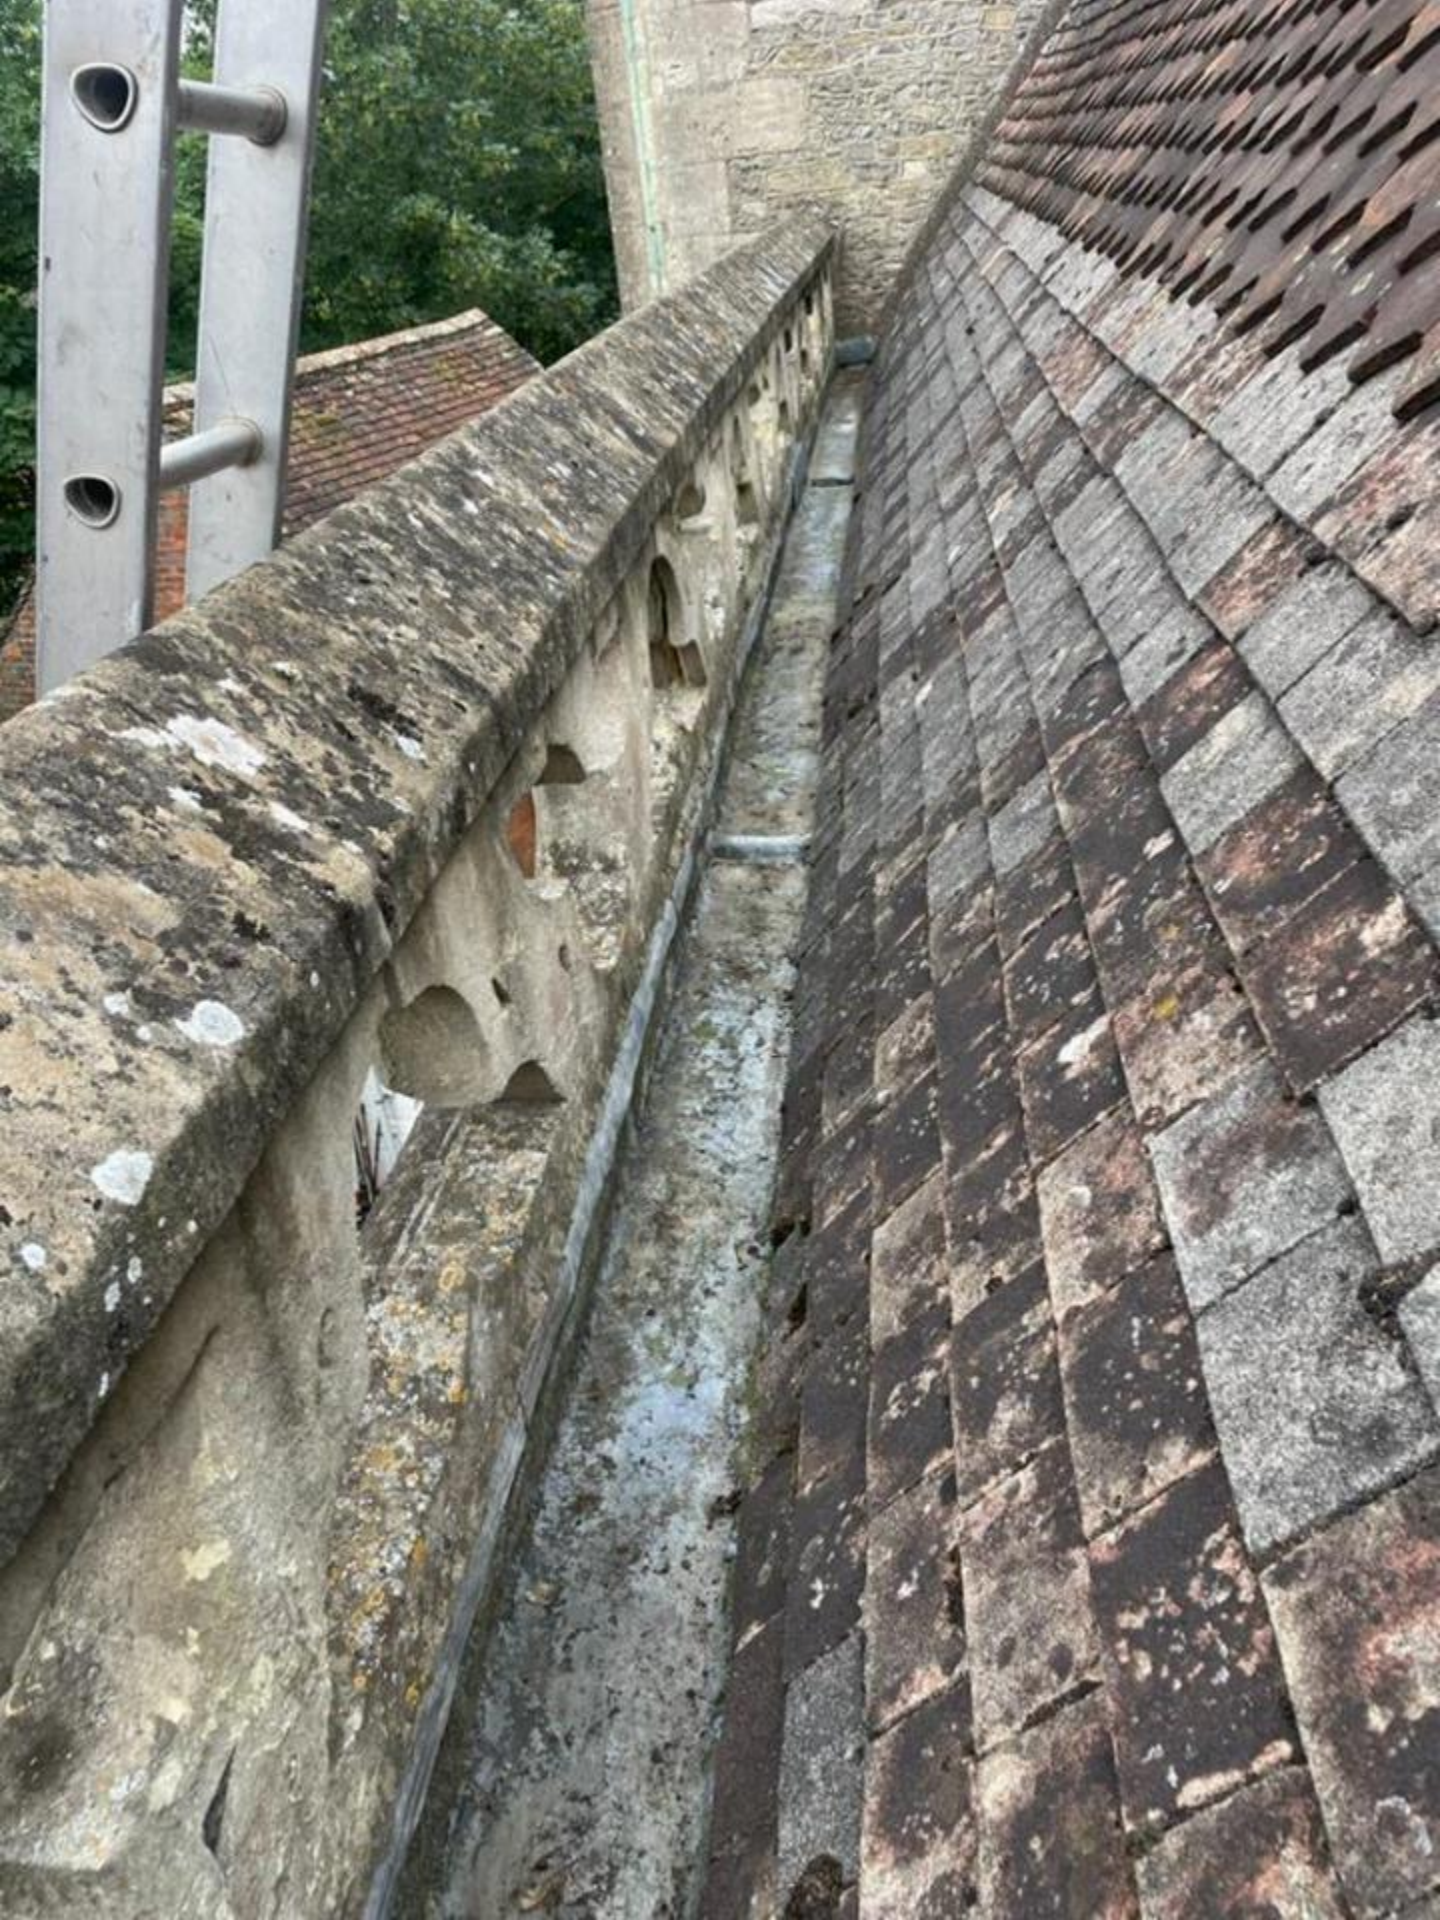
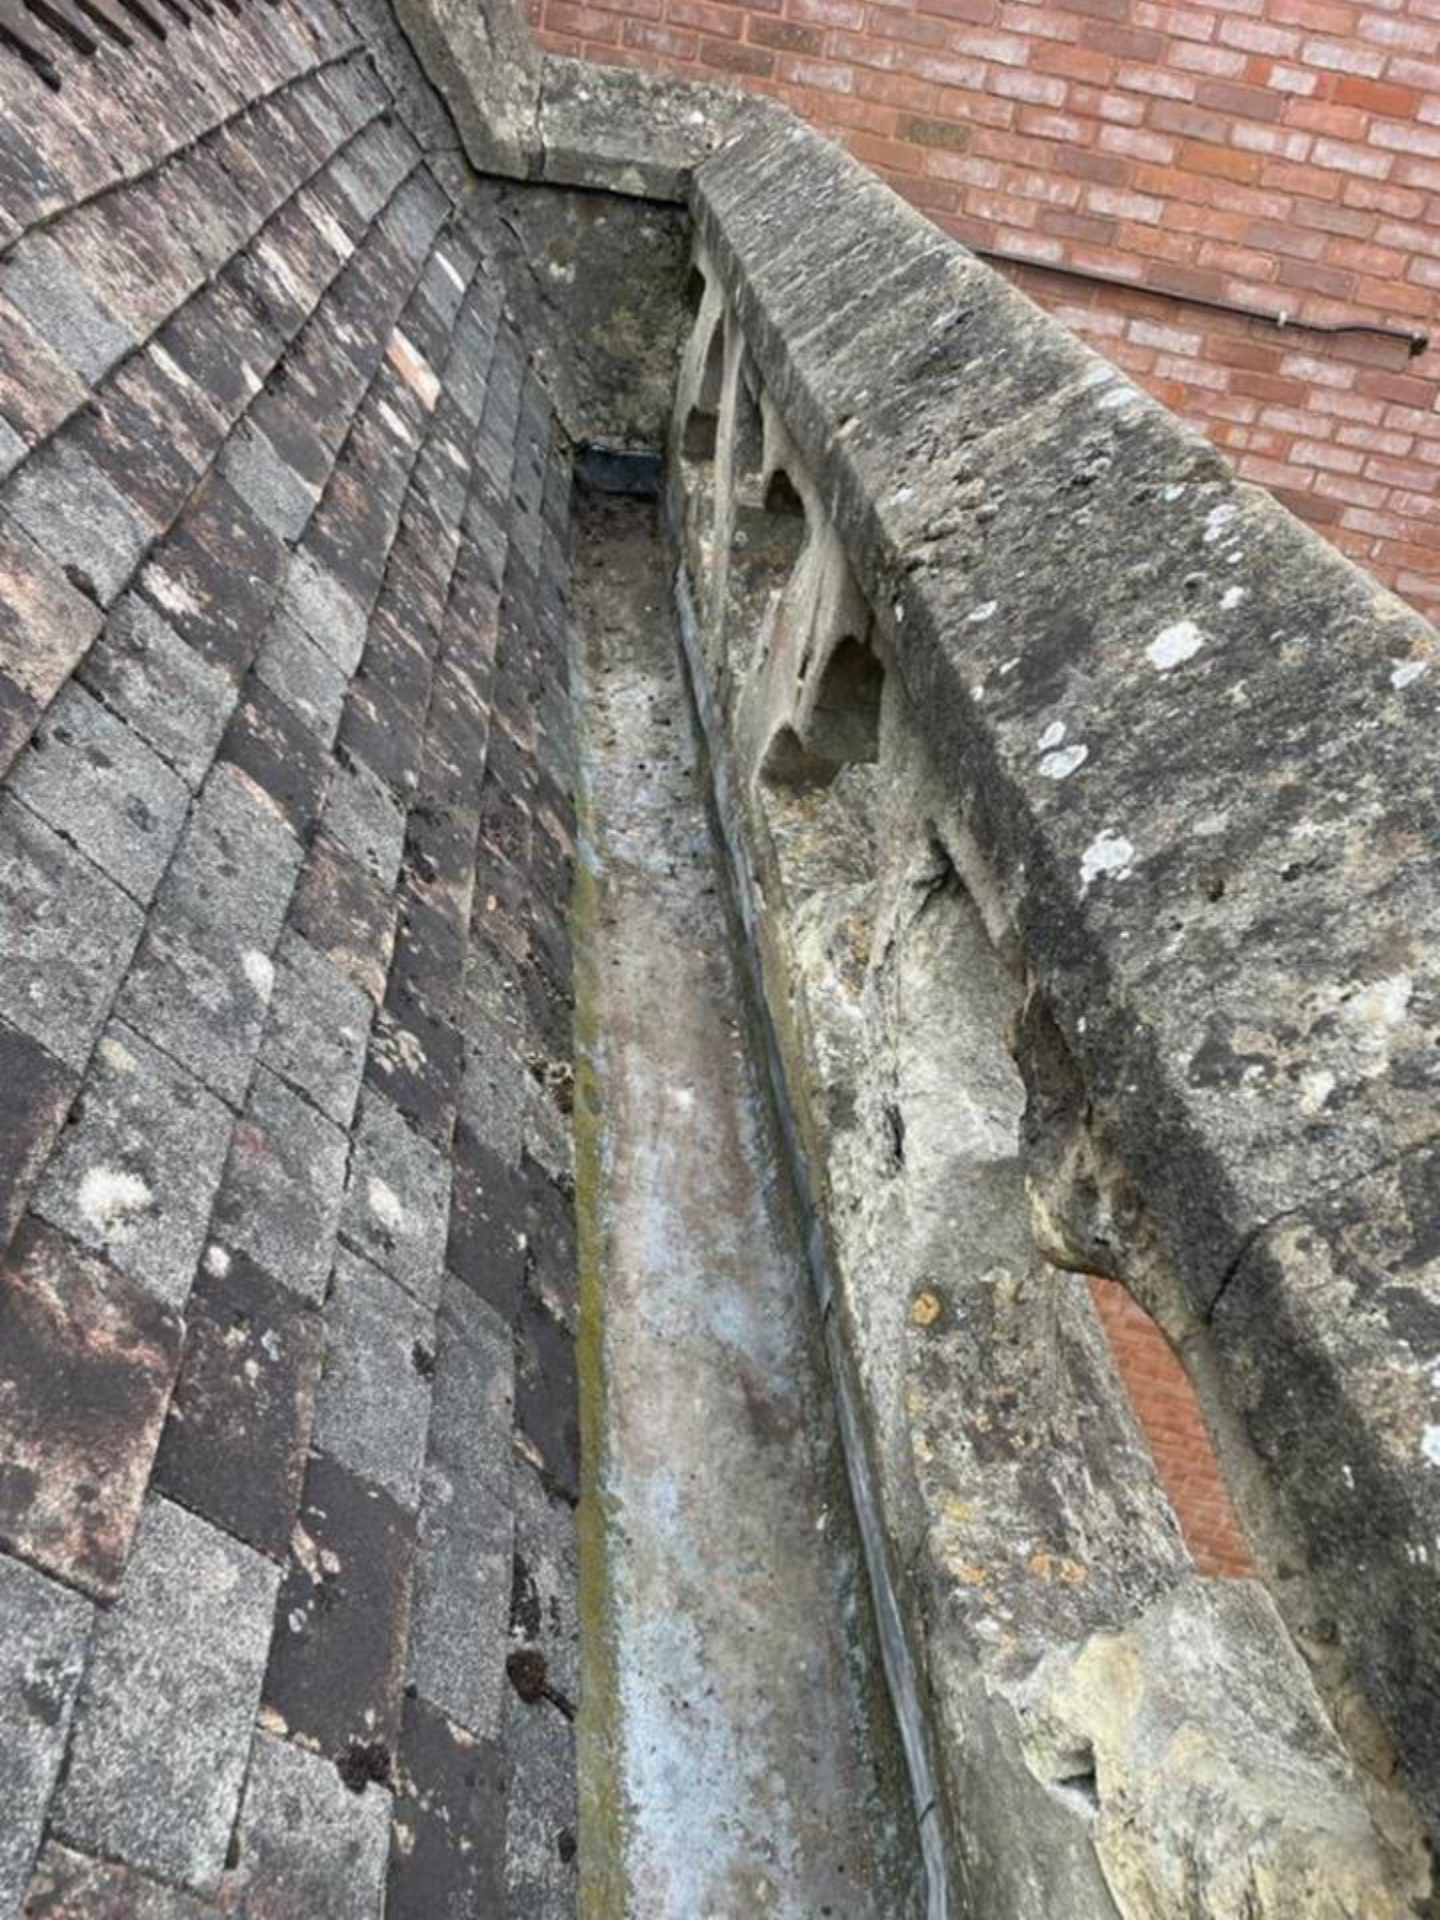
The roof battens and felt seem to be in very good condition. The roofer has clean the debris from the lead gutters on both sides of the chapel and replaced some missing tiles, the roof seems to be in very good condition. The cover lead flashing to the decorative parapet is starting to come away in area because the mortar pointing is on the move.
