St Lawrence Chapel Warminster East Window Repairs May to August 2023

Warminster, St Lawrence Chapel

East Window, Pre-restoration

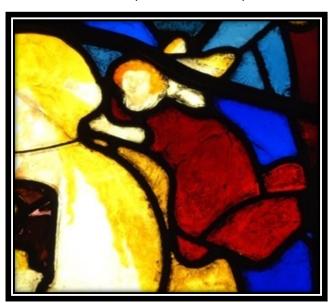
19th century glass

If the correct temperature is not reached the paint cannot fuse with the glass surface and remains on the surface, in a condition that renders it susceptible to deterioration in the presence of moisture (water soluble).

Over time if this glass is in a situation where condensation is an issue, the continuous wetting and drying cycles will slowly remove the painted detail from the glass and at its worst leave no artwork on the glass at all.

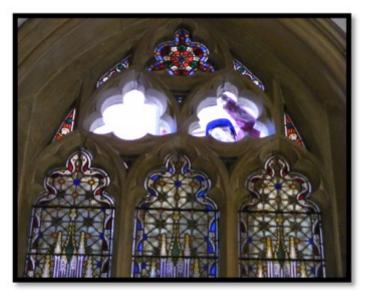
Removal of the glazing from the stonework

All glazing panels were removed <u>from the stonework</u>, to the workshop. Rubbings of each panel taken and marked with CVMA <u>notations</u>, photographs of each panel taken on the light box prior to de-glazing. Wire guards take down and put aside for later re-instatement.

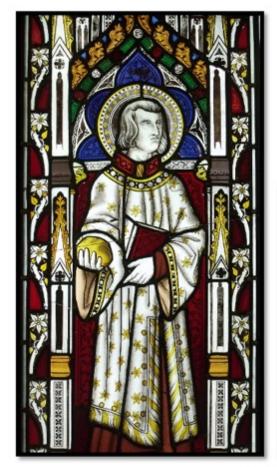
Fine qualities of painted detail

The glass was found to be in a well fired stable condition, with only the leadwork being of real concern. The artist responsible for this window has not been identified, but close inspection of the painted detail reveals someone of considerable talent, especially in the areas of grisaille detail that forms the background to the figures.

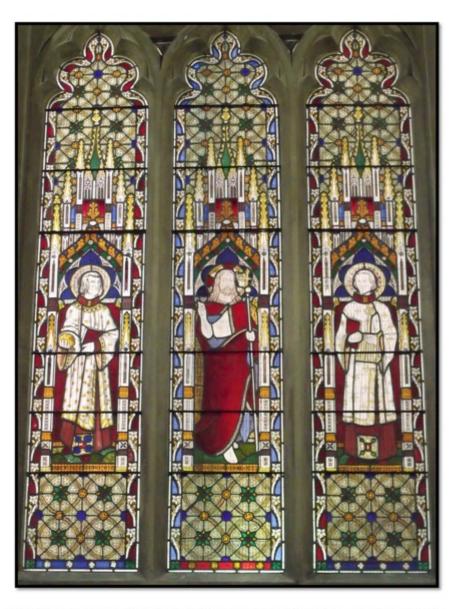
Those areas of movement in the tracery stonework were drilled and pinned using non-ferrous bar, to stabilise.

External wire guards were re-instated and fixed with non-ferrous plug and screw fixings.
